INSPECTION REPORT

Report Number
RHI 4561

Some City, Minnesota 55000

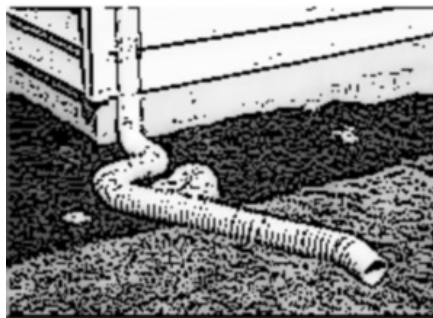
LOCATION: Exterior Rear

SYSTEM: Roof

RECOMMENDED ACTION: Maintenance

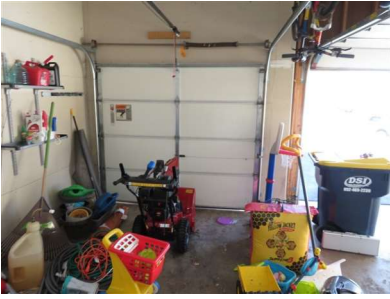
LOCATION: Garage Vehicle Door (single door) **SYSTEM:** Exterior
CONDITION: Vehicle door opener operation unsatisfactory. (hold button)
EXPLANATION: The vehicle door opener button must be held in to close the door completely. The home inspector is not required to correct these conditions to evaluate the opener.

NOTE: This condition may prevent the home inspector from fully evaluating the vehicle door.

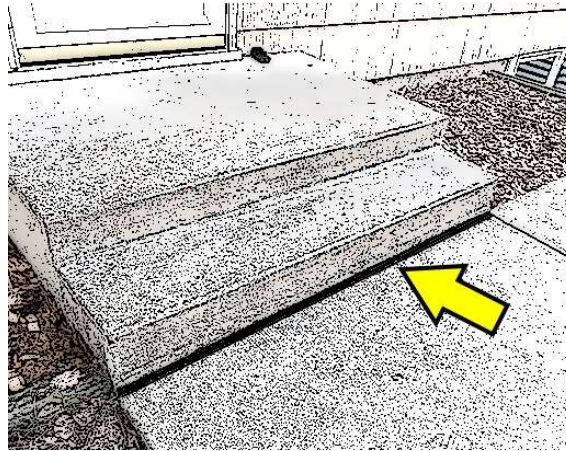
LOCATION: Exterior Rear **SYSTEM:** Exterior

CONDITION: Concrete pad has separated from structure

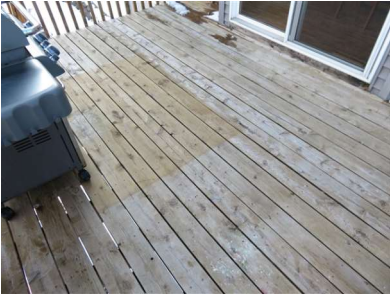
LOCATION: Deck **SYSTEM:** Exterior

CONDITION: **Unprotected wood surfaces (general maintenance)**

RECOMMENDED ACTION: Monitor; Replace should severe wood rot, deterioration, or corrosion be observed | Consult Specialist | Recommended Upgrade

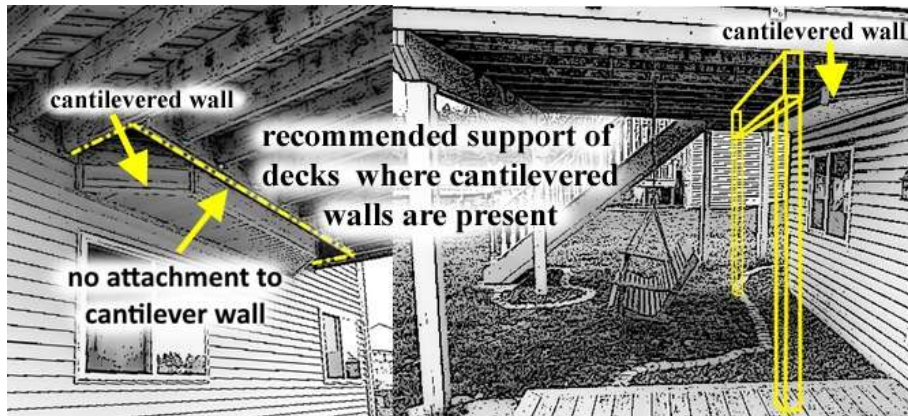
LOCATION: Deck **SYSTEM:** Exterior

CONDITION: Support column (post) is out of plumb

RECOMMENDED ACTION: Repair | Maintenance | Consult Specialist

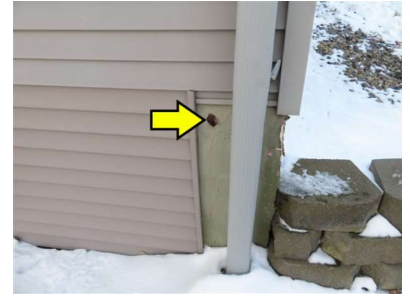
LOCATION: Foundation - Various Locations

SYSTEM: Exterior

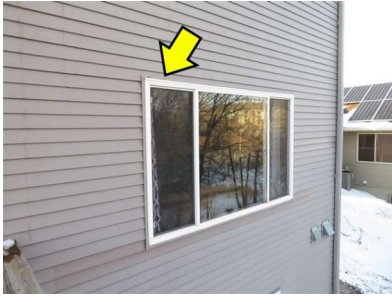
LOCATION: Exterior Rear **SYSTEM:** Exterior

CONDITION: Vinyl siding damaged (minor)

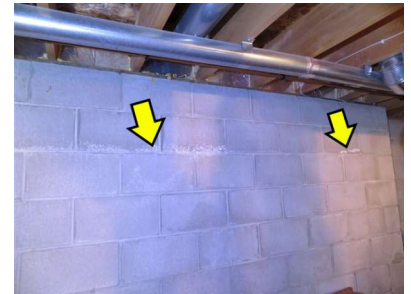
LOCATION: Foundation - Interior Front, Left **SYSTEM:** Structure

CONDITION: Efflorescence is observed on foundation

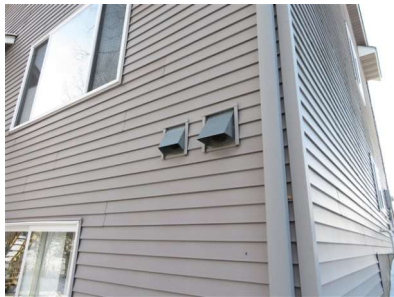
LOCATION: Exterior Rear **SYSTEM:** Insulation/Ventilation

CONDITION: Fresh air intake vent maintenance recommendation

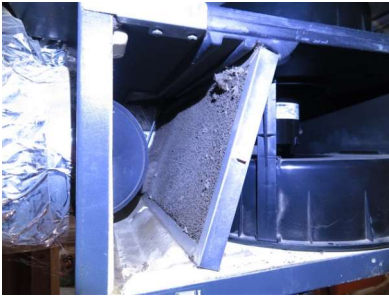
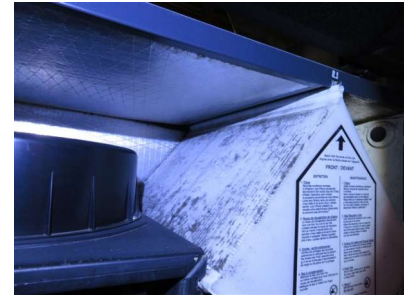
LOCATION: HRV (Heat Recovery Ventilator/ Air Exchanger) **SYSTEM:** Heating/Cooling
CONDITION: The HRV / Air exchange unit and filters need maintenance

EXPLANATION: The HRV/Air Exchanger filters were observed to be dirty or clogged such that proper performance of this appliance may not be possible. The HRV keeps the home supplied with a steady flow of fresh outdoor air. As stale, warm air is expelled, the heat recovery core warms the incoming fresh, colder air before it is distributed throughout the home. The result is a constant supply of fresh air, no unpleasant drafts and greater home comfort. In addition to heat recovery and improved air quality, the HRV provides necessary ventilation while controlling excess humidity. Periodic maintenance of the HRV is required to prevent the filters and core from becoming clogged.

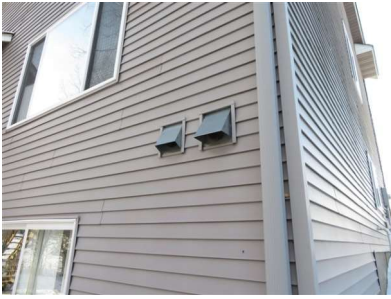
LOCATION: Exterior Rear **SYSTEM:** Heating/Cooling
CONDITION: The HRV / Air exchange exterior vent maintenance recommendation

EXPLANATION: Regular maintenance of the exterior vent screens is recommended to allow for the free flow of incoming air.

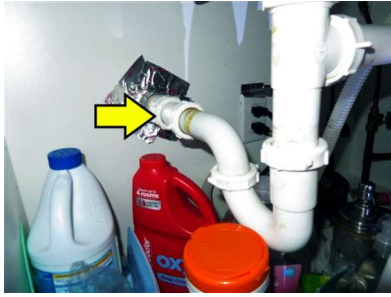
LOCATION: Kitchen **SYSTEM:** Plumbing

CONDITION: Drain pipe configuration non-conforming (**multiple slip joints**)

RECOMMENDED ACTION: Health Concern | Review | Repair | Consult Specialist

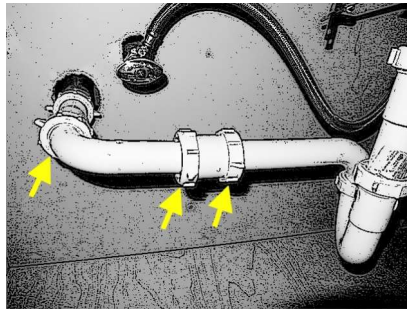
LOCATION: Kitchen **SYSTEM:** Plumbing

CONDITION: Drain pipe configuration or connection from dishwasher non-conforming

RECOMMENDED ACTION: Health Concern | Replace, Repair, or Adjust

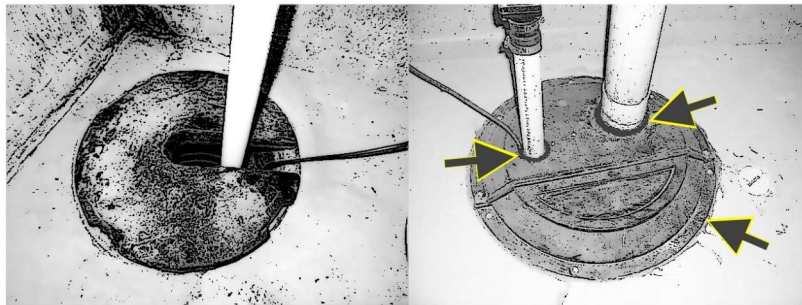
LOCATION: Sump Pump Basket Cover **SYSTEM:** Plumbing

open sump basket covers
should be sealed

sealed covers prevent soil
gases and moisture from
migrating to the interior
of the home

RECOMMENDED ACTION: Safety Concern | Health Concern | Recommend Sealing

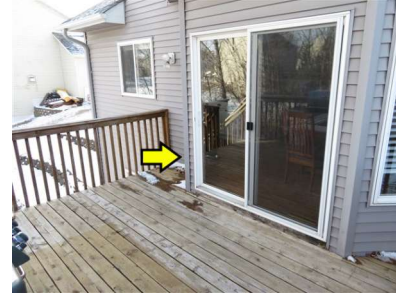
LOCATION: Exterior Outlets **SYSTEM:** Electrical

CONDITION: Exterior electrical weather resistant outlet cover outdated

RECOMMENDED ACTION: Safety Concern | Consult Specialist

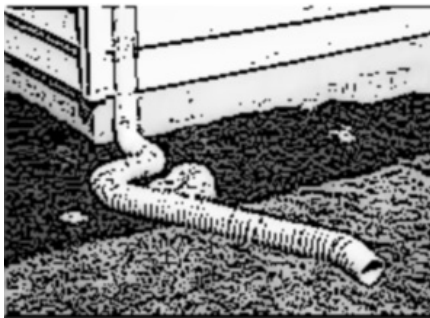
2

**LOCATION:** Downspouts - Various Locations **SYSTEM:** Roof**CONDITION:** Downspout tail piece performance is suspect (ribbed extension)**EXPLANATION:** A section of the downspout is observed to be of a style, type, or configuration that does not appear to be suitable to assuring discharge water will be free flowing and discharge away from the foundation wall effectively. This may include flexible or "ribbed" sections, slope, or drain tile. Ribbed drains do not rinse clean causing a build-up of debris within the downspout causing blockage, which may attract rodents which may nest in the ribbed section of the downspout causing additional blockage.**IMPACT/CONSEQUENCES:** Downspouts are a key component in the controlled drainage of run-off water away from the home's exterior elements. Poorly designed or configured downspout end terminations may result in water saturation of soils near the foundation during rains, which in turn can result in basement moisture or leakage issues. It is recommended that the point of discharge be at least 6' (2 m) from the foundation; repair should include replacing the downspout extension. The downspout assembly should assure that water freely flows and drains at a suitable distance from the foundation wall.**RECOMMENDED ACTION:** Monitor closely.

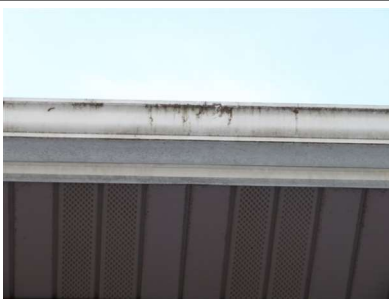
3

**LOCATION:** Exterior Rear **SYSTEM:** Roof**CONDITION:** Gutter appears to have overflowed**EXPLANATION:** The gutter displays indications that it has overflowed. This is usually an indication that debris has built up in the gutters, such that the free flow of water has been restricted to some degree causing the gutter to fill and overflow.**IMPACT/CONSEQUENCES:** Gutters are a key component in the controlled drainage of run-off water away from the home's exterior elements. Water backing up in the gutter may add sufficient weight to the gutter to cause its detachment from the structure. Gutters that do not perform as intended may result in saturation of soils near the foundation, which in turn can result in basement moisture or leakage issues. Repair should include removing debris and assuring that water freely flows and drains from the gutter.**RECOMMENDED ACTION:** Maintenance

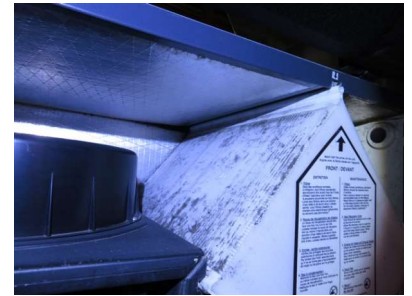
6

LOCATION: HRV (Heat Recovery Ventilator/ Air Exchanger) **SYSTEM:** Heating/Cooling

CONDITION: The HRV / Air exchange unit and filters need maintenance

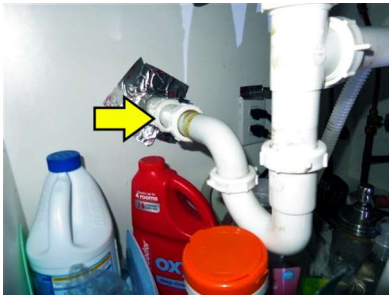
10

LOCATION: Kitchen **SYSTEM:** Plumbing

CONDITION: Drain pipe configuration non-conforming (**multiple slip joints**)

RECOMMENDED ACTION: Health Concern | Review | Repair | Consult Specialist

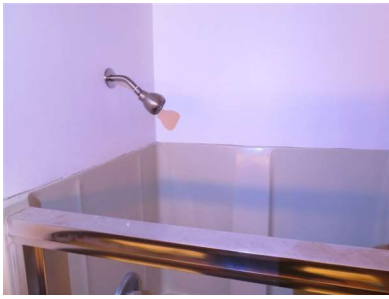
15

LOCATION: Bathroom - Master **SYSTEM:** Plumbing

CONDITION: Shower enclosure top edge requires effective sealing.

RECOMMENDED ACTION: Repair | Consult Specialist

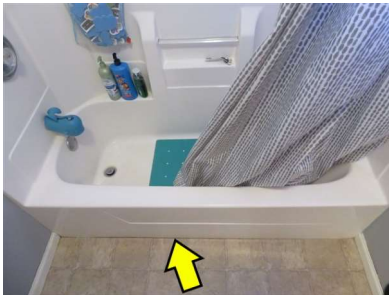
16

LOCATION: Bathroom - Master, Upper **SYSTEM:** Plumbing

CONDITION: Caulking is incomplete or open at bathtub edges, shower/bathtub and floor junction, or shower/bathtub wall junction inside and outside the plane of the shower or tub

RECOMMENDED ACTION: Repair | Maintain as required to prevent infiltration | Consult Specialist

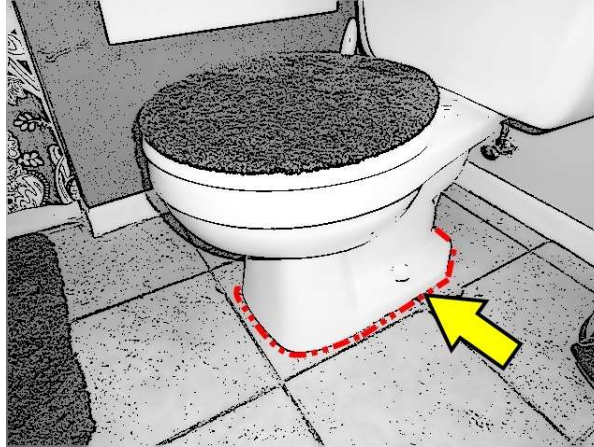
- 17** **LOCATION:** Bathroom - Master, Upper **SYSTEM:** Plumbing
CONDITION: Caulking between toilet and floor is deteriorated, missing, or incomplete.
EXPLANATION: Seal is missing between toilet and floor to prevent water intrusion.
IMPACT/CONSEQUENCES: Caulking should be installed to prevent water intrusion between toilet and floor.
RECOMMENDED ACTION: Repair

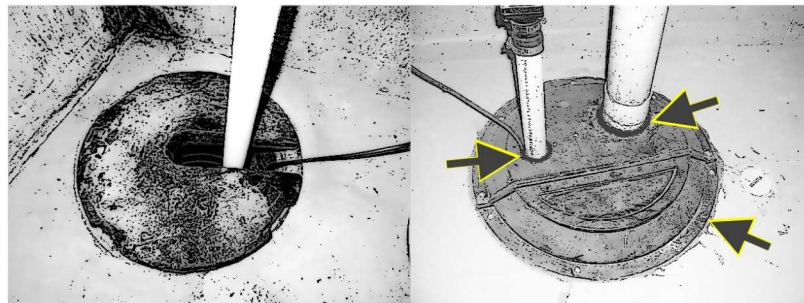
open sump basket covers should be sealed

sealed covers prevent soil gases and moisture from migrating to the interior of the home

RECOMMENDED ACTION: Safety Concern | Health Concern | Recommend Sealing

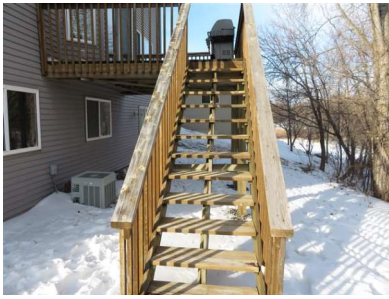
32

LOCATION: Deck SYSTEM: Exterior

CONDITION: **Exterior stair hand railing/guard is missing or non-conforming**

RECOMMENDED ACTION: **Safety Concern** - Recommended Installing

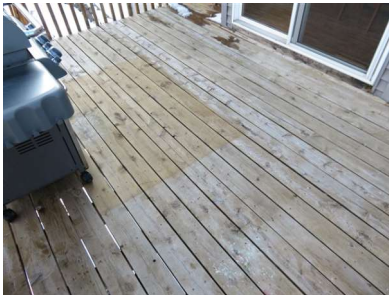
33

LOCATION: Deck **SYSTEM:** Exterior

CONDITION: Unprotected wood surfaces (general maintenance)

RECOMMENDED ACTION: Monitor; Replace should severe wood rot, deterioration, or corrosion be observed | Consult Specialist | Recommended Upgrade

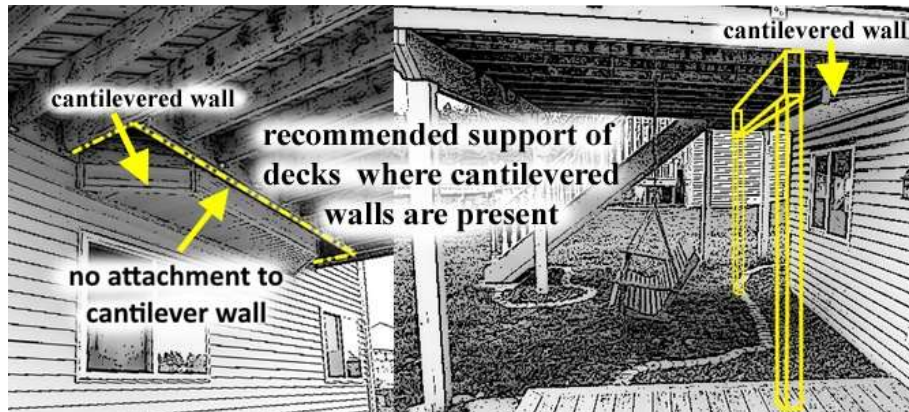
**LOCATION:** Deck **SYSTEM:** Exterior**CONDITION:** Cantilevered Wall / Deck attachment concerning**EXPLANATION:** The deck is observed to be attached to and supported by a cantilevered wall. This method of supporting the deck is a concern because the cantilevered wall may not have been designed to support the additional weight of the deck. Additional support columns and beams or properly framing the deck around the cantilevered wall are usually recommended and used to support this area of the deck.**IMPACT/CONSEQUENCES:** Improperly configured and supported decks attached to cantilevered walls may over time cause sagging and eventually structural failure of the cantilevered wall. Determining the weight bearing capacity of the cantilevered wall is beyond the scope of the inspector. This condition should be evaluated by a licensed contractor that is familiar with current methods and regulations for deck construction, to assure the deck attachment and support meets the current standards, local jurisdiction requirements, or the actual designed and anticipated load requirements of the deck.**RECOMMENDED ACTION:** Safety Concern | Review | Consult Specialist

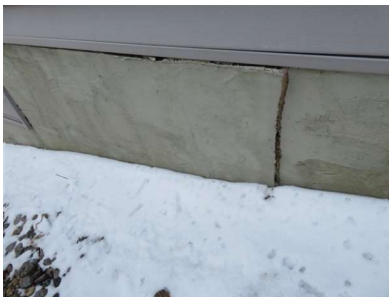
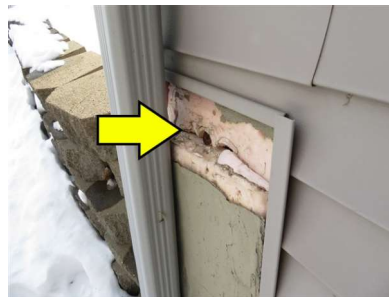
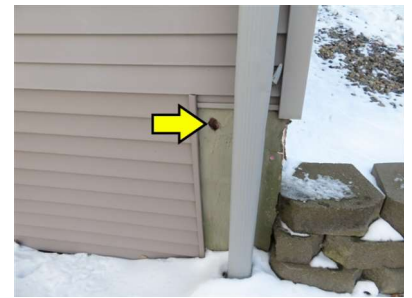
40

LOCATION: Foundation - Various Locations **SYSTEM:** Exterior

CONDITION: Exterior foundation insulation system is incomplete, not sealed, loose, damaged, or deteriorated

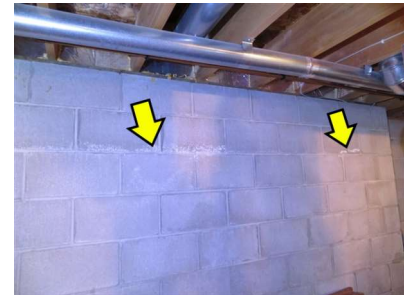
50

LOCATION: Foundation - Interior Front, Left **SYSTEM:** Structure

CONDITION: Efflorescence is observed on foundation

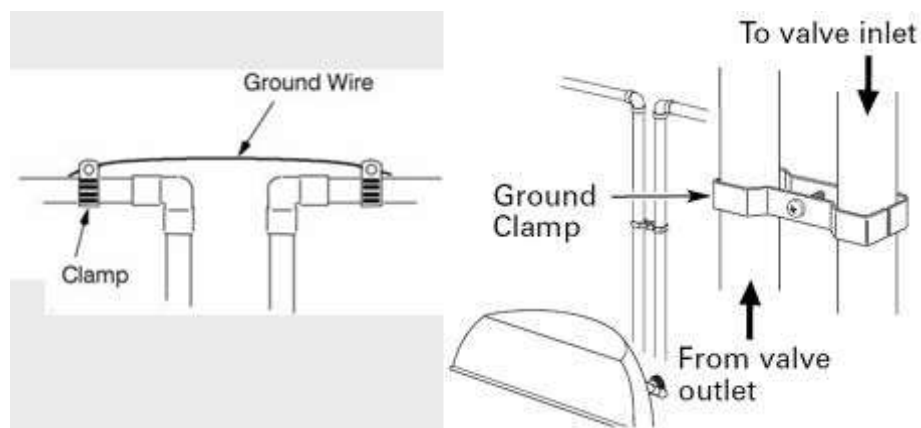
53 LOCATION: Water Conditioner (softener) SYSTEM: Electrical

CONDITION: The bonding jumper wire at the [water conditioner](#) is missing, ineffective, non-conforming, or can not be verified

RECOMMENDED ACTION: Safety Concern | Consult Specialist

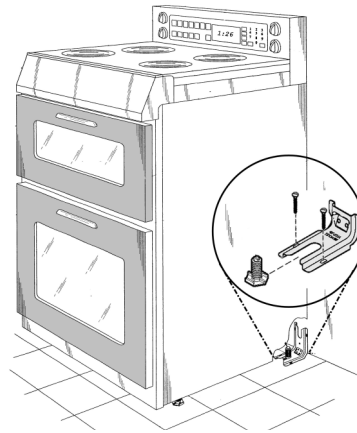
60 LOCATION: Kitchen SYSTEM: Interior**CONDITION:** Anti-tip device is not installed or not installed correctly (Stove)**EXPLANATION:** The appliance was observed not to have any anti-tip device installed or installed correctly to prevent injury from the stove tipping.**IMPACT/CONSEQUENCES:** The appliance could potentially tip over onto someone or tip and spill hot items causing injury. These anti-tip devices can usually be found in the appliance department at most home improvement stores.**RECOMMENDED ACTION:** Recommended Safety Upgrade
