INSPECTION REPORT

Report Number
RHI 4561

Some City, Minnesota 55000

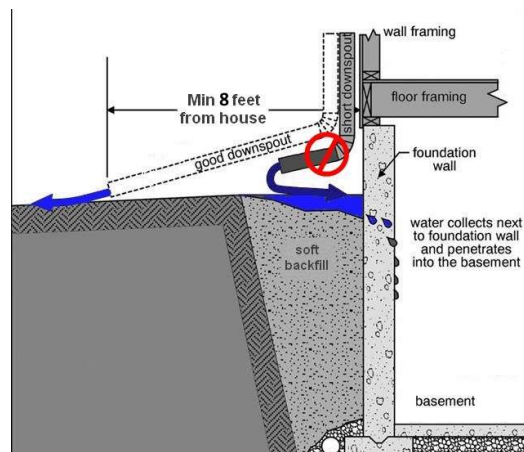
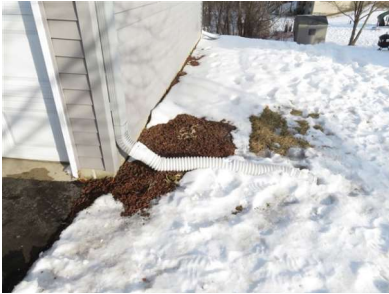
LOCATION: Downspouts - Various Locations

CONDITION: Downspout tail piece performance is suspect (ribbed extension)

IMPACT/CONSEQUENCES: Downspouts are a key component in the controlled drainage of run-off water away from the home's exterior elements. Poorly designed or configured downspout end terminations may result in water saturation of soils near the foundation during rains, which in turn can result in basement moisture or leakage issues. It is recommended that the point of discharge be at least 6' (2 m) from the foundation; repair should include replacing the downspout extension. The downspout assembly should assure that water freely flows and drains at a suitable distance from the foundation wall.

RECOMMENDED ACTION: Monitor closely.

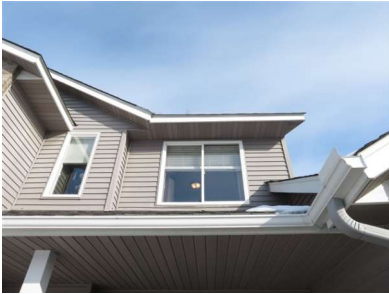
LOCATION: Roof - Front (upper) **SYSTEM:** Roof

CONDITION: **Gutters not installed at all areas of roof edge**

IMPACT/CONSEQUENCES: Gutters are a key component in the controlled drainage of run-off water away from the home's exterior elements. Roof runoff can deteriorate the siding, foundation, and foundation covering and insulation systems, saturate soils near and/or under driveways, walkways, steps, patios, and footings of decks and stairways causing settlement, cracking, and may eventually cause major deterioration, settlement, or heaving, and can result in basement moisture or leakage issues resulting in organic growth (mold, mildew, fungus, etc.).

RECOMMENDED ACTION: Recommend Installing | Consult Specialist

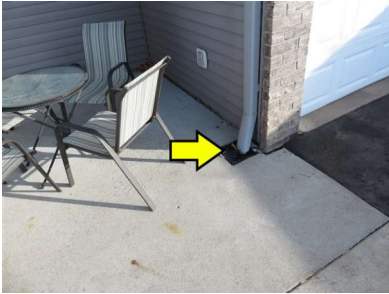
LOCATION: Downspouts - One or More Locations **SYSTEM:** Roof

CONDITION: Downspout below grade or hidden drainage provisions are concerning

Consulting a gutter Specialist is advised to discuss options to address this condition.

RECOMMENDED ACTION: Review | Monitor | Repair | Consult Specialist

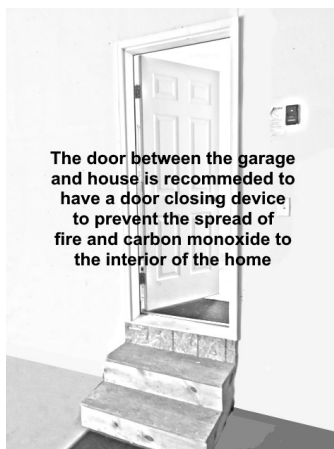
IMPACT/CONSEQUENCES: A door that connects the house with an attached garage, when it does not close and latch under the control of a suitable door closer or when it is missing, may be considered a safety concern, as fumes and fire from the garage may migrate and spread into the house. A mechanism for door closure when installed correctly, helps ensure the door automatically closes, latches, and seals when the door is released. Adjustments to the door or door hardware may be necessary for the correct operation of the door closer.

RECOMMENDED ACTION: **Safety Concern | Fire and Safety Upgrade Recommendation**

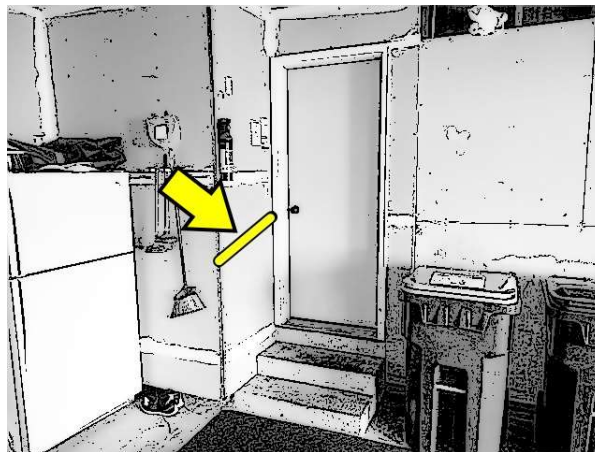
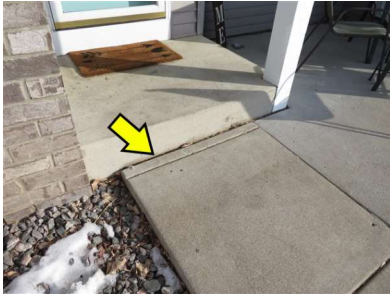
LOCATION: Exterior Front **SYSTEM:** Exterior

CONDITION: Walkway/stairway junction has **open gaps, cracks, or seams.**

IMPACT/CONSEQUENCES: This condition may promote undesired effects, which may include issues such as moisture problems at the home's foundation, soil erosion, or settling and heaving of the concrete walkway or step. Filling this gap with a nonabsorbent material such as expandable foam to prevent additional frost push is recommended by many professionals. Large gaps may be a **SAFETY CONCERN** by creating a trip hazard and causing injury. Advice from a Specialist is recommended especially for larger separations.

RECOMMENDED ACTION: Repair | Replace | Consult Specialist

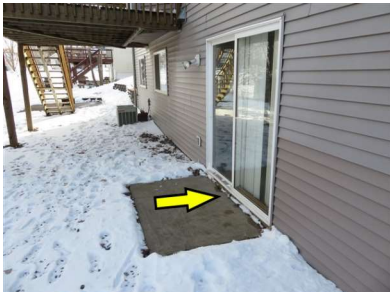
LOCATION: Exterior Rear **SYSTEM:** Exterior

CONDITION: Concrete pad has separated from structure

IMPACT/CONSEQUENCES: Gaps between the pad and structure are susceptible to moisture accumulation and frost expansion which may promote additional separation. The gaps should be properly filled with a nonabsorbent material and caulked. Review by a concrete Specialist for suggestions of remedial action is recommended.

RECOMMENDED ACTION: Recommend Review by a Specialist

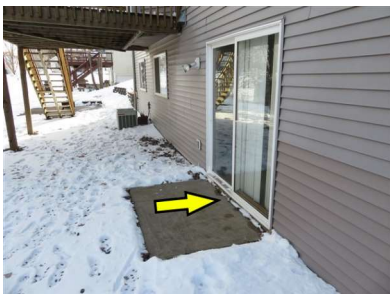
LOCATION: Exterior Rear **SYSTEM:** Exterior

CONDITION: Concrete pad or landing is sloped towards foundation -

IMPACT/CONSEQUENCES: Concrete pads and landings should be sloped to promote drainage away from the foundation of the house or garage. Water accumulation near the foundation may lead to foundation and basement dampness issues. In some cases, frequent saturation of soils may result in erosion of soils below the footings, and in combination with soil pressure and frost heave, can result in damage to the foundation. Sealing of seams between the concrete pad/landing and structure is recommended. Replacement may have to be considered.

RECOMMENDED ACTION: Repair | Consult Specialist

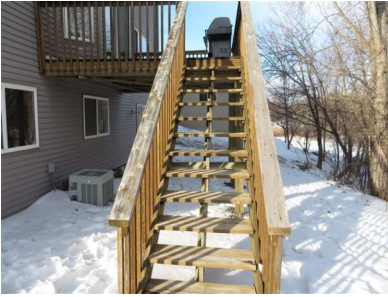
LOCATION: Deck SYSTEM: Exterior

CONDITION: **Exterior stair hand railing/guard is missing or non-conforming**

IMPACT/CONSEQUENCES: The primary function of interior railings is to protect people from falling and being injured. There is indication of poor design, construction, or maintenance, such that the railings do not appear to be in a condition that meets its intended function of protecting people from the risk of injury. Failure to correct railing deficiencies is a safety issue, and in some cases may have legal consequences where a person is injured as a result of neglecting to provide adequate safety provisions.

RECOMMENDED ACTION: **Safety Concern** - Recommended Installing

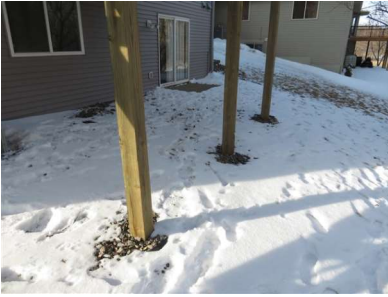
LOCATION: Deck **SYSTEM:** Exterior

CONDITION: Support column (post) concerning - Not on a footing raised to recommended minimum height

IMPACT/CONSEQUENCES: Support columns that are in contact with or close to the ground or horizontal surface will tend to rot or rust at the bottom, as they are in a environment where the lower portion of the column will be damp over extended periods of time. Although some natural and treated woods are more resistant to rot than others, all wood will over time deteriorate when in contact with the ground and soil moisture. In addition to the deterioration concerns of the wood support columns, is the damage that may occur to the bottom of the columns as they wick moisture during colder climates and then go through freeze/thaw cycles which may expand and shred, tear, or "mushroom out" the bottom of the column resulting in ongoing damage and deterioration over time. Metal columns will also deteriorate (rust / corrode) when exposed to damp conditions for extended periods of time. The columns should be periodically monitored for; changes in the condition and loss of integrity. Replacement of the columns, if and when necessary, by a licensed contractor is advised. Note that the columns are crucial to the support structure of the deck, balcony, or stairway and structural failure may occur should the columns(s) deteriorate to a degree that they can not bear their intended load.

RECOMMENDED ACTION: Monitor; Replace should severe wood rot, deterioration, or corrosion be observed | Consult Specialist | Recommended Upgrade

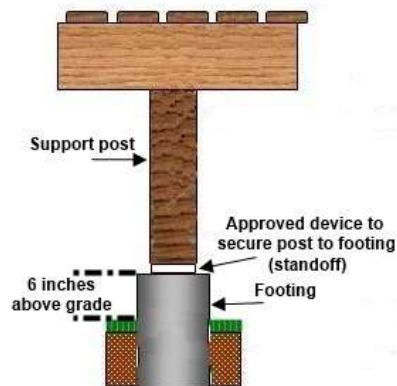
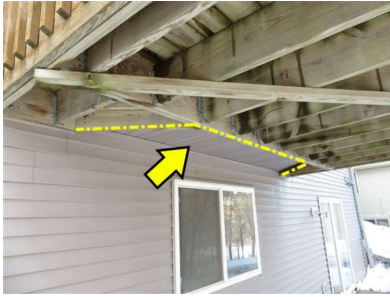
LOCATION: Deck **SYSTEM:** Exterior

CONDITION: **Cantilevered Wall / Deck attachment concerning**

IMPACT/CONSEQUENCES: The ability of the column to bear its intended load, as well as the current and future stability of the column to bear loads, is a concern where a column exhibits either of the above out-of-plumb conditions. A review of the condition by a Specialist is recommended. Alteration of columns should only be done under the direction of a Specialist.

RECOMMENDED ACTION: Consult Specialist

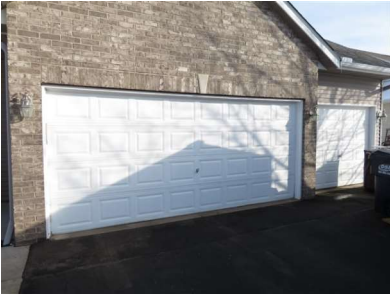
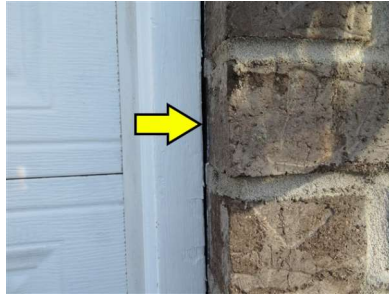
LOCATION: Garage Vehicle Door **SYSTEM:** Exterior

CONDITION: **Garage vehicle door trim / wall cover junction requires caulking (general)**

IMPACT/CONSEQUENCES: Caulking at these seams serves several functions, including preventing air, water, and pest infiltration, and restricting heat loss or gain through the exterior wall. Moisture has the greatest potential for damage; unintended water infiltration into the house can cause significant damage to surfaces and property, and if not corrected, may lead to damage and rot to structural elements. Caulking repairs are required at the noted location(s), and should be performed at the earliest opportunity. Preventative maintenance should include reviewing and repairing exterior caulking at all locations where required.

RECOMMENDED ACTION: Repair | Maintenance | Consult Specialist

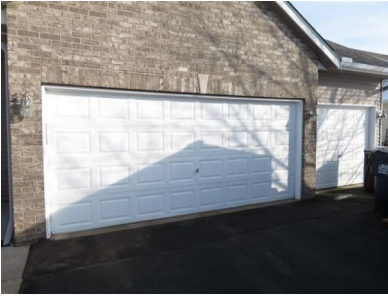
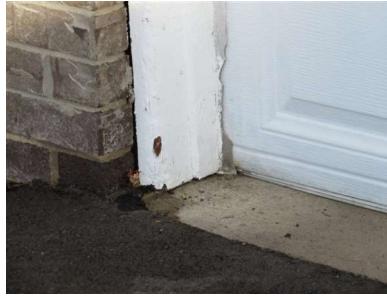
LOCATION: Garage Vehicle Door **SYSTEM:** Exterior

CONDITION: **Vehicle door trim** requires maintenance (paint, caulk, repair)

IMPACT/CONSEQUENCES: Failure to properly maintain exterior finishes will result in deterioration of the trims and wood elements, and left uncorrected, may result in water infiltration and damage to the wall structure or infiltration to interior elements.

RECOMMENDED ACTION: Recommended Maintenance

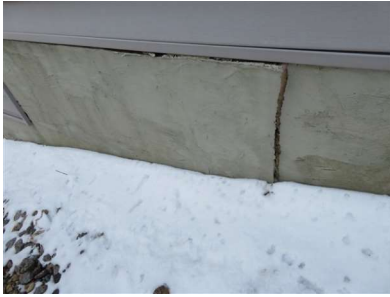
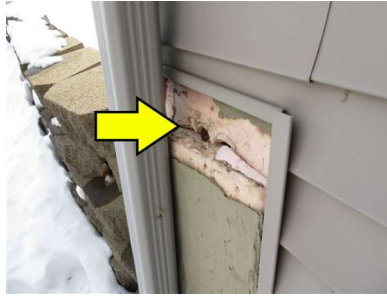
LOCATION: Foundation - Various Locations

IMPACT/CONSEQUENCES: Areas of foundations with incomplete, unsealed, loose, damaged, or deteriorated insulation coatings or coverings are vulnerable to adverse effects of the weather. The foundation wall insulation may become susceptible to water infiltration and may not be able to perform as expected. The protective coatings that is incomplete, unsealed, loose, damaged, or deteriorated foundation insulation should be replaced, repaired, and/or properly attached to function as intended.

RECOMMENDED ACTION: Repair/Replace

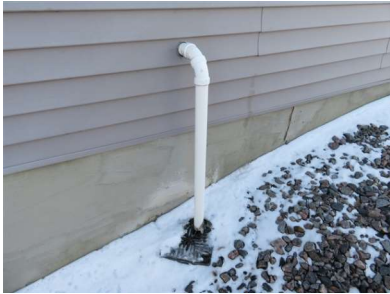
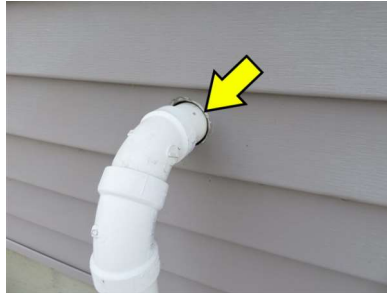
LOCATION: Exterior Left Side

IMPACT/CONSEQUENCES: Unintended water infiltration into the house can result in significant damage to surfaces and property, and if not corrected, may lead to damage and rot to structural elements. Unintended air infiltration may affect interior air quality and conditioning. Unintended pest entry can result in damage to interior finishes and belongings, and in some cases may present health risks. Corrective action is required to seal all openings through the exterior wall system.

RECOMMENDED ACTION: Repair

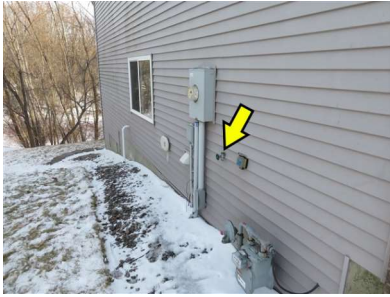
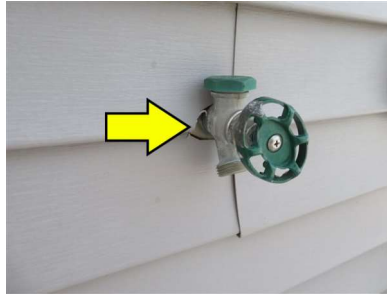
LOCATION: Exterior Left Side **SYSTEM:** Exterior

CONDITION: Wall penetration of faucet or water supply pipe is not caulked/sealed at exterior wall

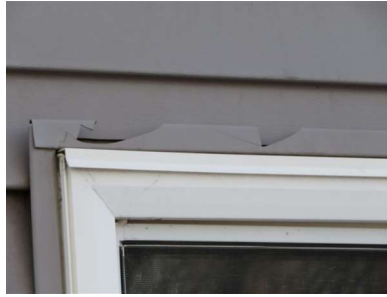
LOCATION: Exterior Rear **SYSTEM:** Exterior

CONDITION: Vinyl siding damaged (minor)

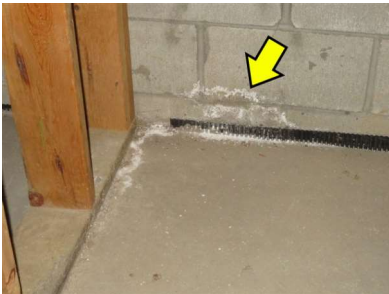
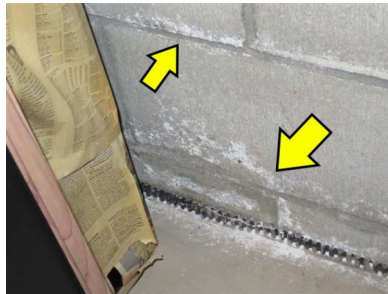
LOCATION: Foundation - Interior Front, Left **SYSTEM:** Structure

CONDITION: Efflorescence is observed on foundation

IMPACT/CONSEQUENCES: Efflorescence is a consequence of moisture drawing out salts in the masonry or concrete, and depositing it on the surface; it is generally powdery-white in appearance. New masonry and concrete is particularly prone to displaying efflorescence in its first year, but this condition should diminish in extent over time. Ongoing and persistent efflorescence is an indication that excessive trapped moisture is working its way through the wall, and should be investigated by a masonry or foundation specialist for evaluation for cause and to establish remedial action. Failure to correct may result in deterioration or damage with potentially expensive repairs.

RECOMMENDED ACTION: Monitor

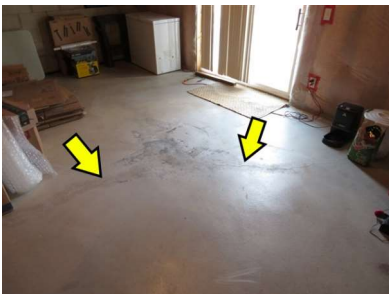
LOCATION: Basement **SYSTEM:** Structure

CONDITION: Indications of past or possibly current water infiltration on concrete floor

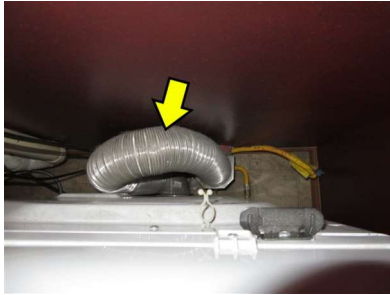
1

**LOCATION:** Laundry Room **SYSTEM:** Interior**CONDITION:** Clothes dryer vent ducting concerning (ribbed)

EXPLANATION: The dryer vent ducting is recommended to be metal (smooth rigid) and of a uniform diameter to the outside. Too much resistance from “ribbed” style ducting ruins efficiency by extending drying times. With enough resistance, the flow becomes so sluggish that the moisture in the air condenses on the pipes. This condensate attracts lint that sticks to the vent walls. Caked-on lint further impedes airflow and is a fire hazard. Extended run times are also hard on dryers, wearing them out more quickly. And finally, overworked dryers start blowing thermal fuses.

IMPACT/CONSEQUENCES: The use of materials other than approved smooth metal dryer vent may create the possibility of a fire hazard and/or may shorten the useful life of this appliance. Seams if taped, should be taped with an approved taping material that can perform well with high temperatures. Non-conforming tape materials may pose a safety concern.

RECOMMENDED ACTION: Safety Concern | Replace

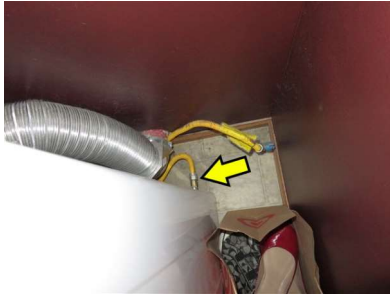
2

LOCATION: Laundry Room **SYSTEM:** Interior
CONDITION: Drip leg missing on gas connection. (Dryer)

EXPLANATION: The drip leg "T" in the gas line to an appliance is not observed where expected or could not be located in the course of inspection. A drip leg should be installed to help catch contaminants in the gas line.

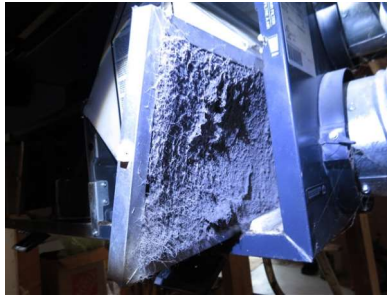
LOCATION: HRV (Heat Recovery Ventilator/ Air Exchanger) **SYSTEM:** Heating/Cooling
CONDITION: The HRV / Air exchange unit and filters need maintenance

EXPLANATION: The HRV/Air Exchanger filters were observed to be dirty or clogged such that proper performance of this appliance may not be possible. The HRV keeps the home supplied with a steady flow of fresh outdoor air. As stale, warm air is expelled, the heat recovery core warms the incoming fresh, colder air before it is distributed throughout the home. The result is a constant supply of fresh air, no unpleasant drafts and greater home comfort. In addition to heat recovery and improved air quality, the HRV provides necessary ventilation while controlling excess humidity. Periodic maintenance of the HRV is required to prevent the filters and core from becoming clogged.

IMPACT/CONSEQUENCES: Dirty filters and core will restrict the air flow through the HRV, which will reduce the efficiency of the unit. Blocked air flow can affect the life expectancy of the unit, may prevent proper defrosting of the unit when in operation, and may affect proper balance of air flow. The unit should be maintained in accordance with the manufacturer's instructions.

The exterior HRV air intake openings should be checked regularly for any build up on the screens which may restrict flow. Professional calibration of this appliance and regular cleaning of the interior and exterior HRV filter(s) is recommended.

RECOMMENDED ACTION: Replace; Clean If Reusable Type

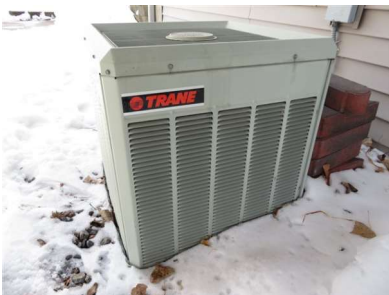
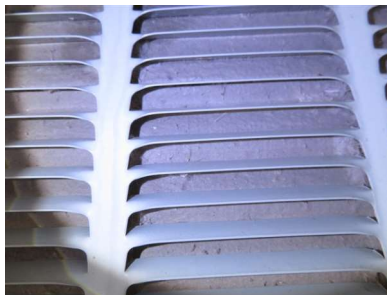
LOCATION: Exterior Rear **SYSTEM:** Heating/Cooling

CONDITION: Condenser unit fins or screen clogged or becoming clogged

EXPLANATION: Dirty fins or screens are noted at the condenser (outside) unit of the air conditioner. This condition may hinder proper operation of this appliance and may result in premature failure.

RECOMMENDED ACTION: Recommended Maintenance

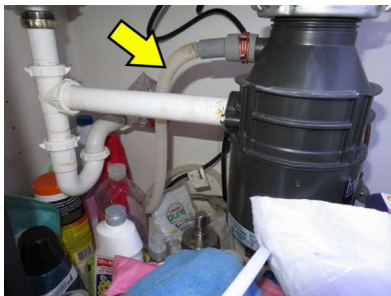
LOCATION: Kitchen **SYSTEM:** Plumbing

CONDITION: Drain pipe configuration or connection from dishwasher non-conforming

RECOMMENDED ACTION: Health Concern | Replace, Repair, or Adjust

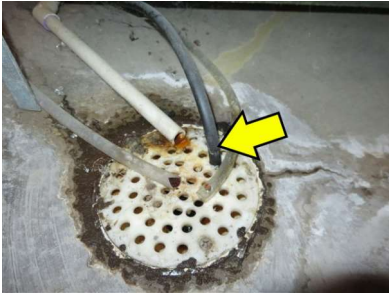
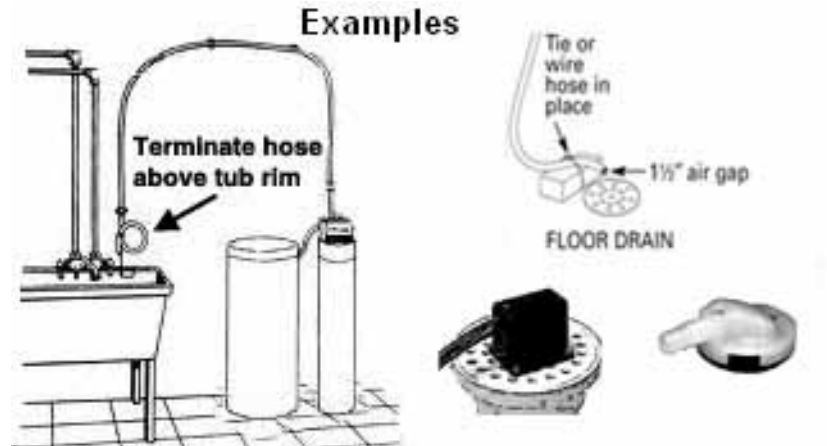
LOCATION: Water Conditioner (softener), Floor Drain **SYSTEM:** Plumbing
CONDITION: Drainage configuration is potential health concern (cross-contamination)

EXPLANATION: The configuration of the drainage piping from the water conditioner allows for the possibility of "cross-contamination" of potable water and gray (waste, contaminated, or unsafe) water. A cross-connection is an unprotected actual or potential connection between a potable water system used to supply water for drinking purposes and any source or system containing unapproved water or a substance that is not or cannot be approved as safe, wholesome, and potable. Although many manufacturers are installing built-in check valves in water softeners, it is important to be aware of this possibility since the presence of a check valve can not usually be verified. The end of a drain, hose, or pipe from a potable water source should not terminate below the rim of a sink, drain, sump pump, waste lift system, or tub. Additionally, there should be a minimum of 1½ inches of separation of the potable drainage piping to a drain grate or floor.

IMPACT/CONSEQUENCES: This drainage configuration is a potential risk to health. A plumber may be required to investigate and implement corrective rework to assure proper installation of the drainage system and components to prevent backflow and contamination of the potable water system.

RECOMMENDED ACTION: Health Concern | Repair | Consult Specialist

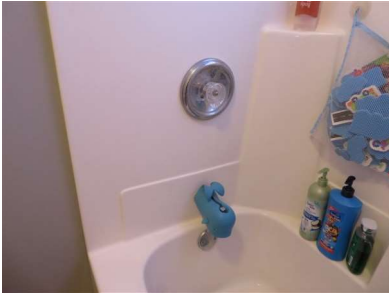
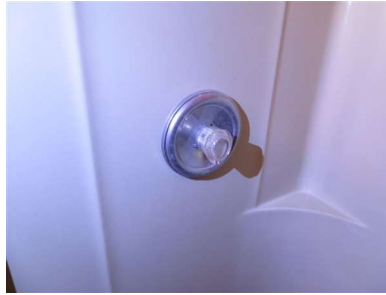
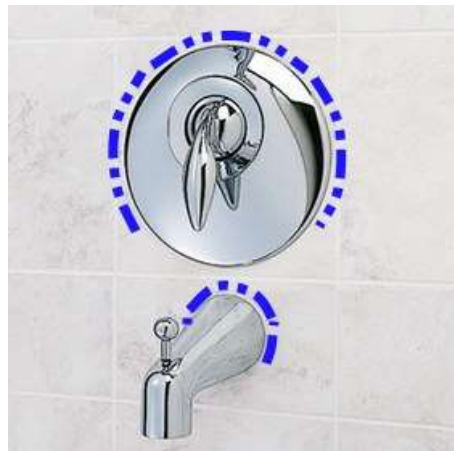
LOCATION: Bathroom - Master **SYSTEM:** Plumbing

CONDITION: Caulking is incomplete at bathtub/shower spout, taps, or wall penetrations

IMPACT/CONSEQUENCES: Caulking is a preventative action to keep water from seeping into walls, and causing damage associated with leaks. Failure to provide effective sealing can result in damage and costly repairs.

RECOMMENDED ACTION: Repair

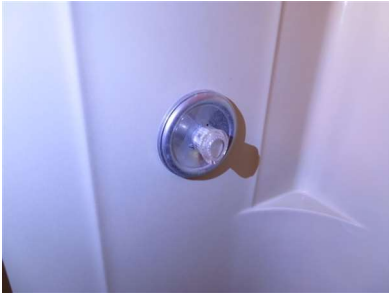
LOCATION: Bathroom - Master **SYSTEM:** Plumbing

CONDITION: Shower tap installation concerning (loose)

IMPACT/CONSEQUENCES: The faucet should be installed correctly so it may be used as intended and it can remain sealed to prevent water infiltration behind the faucet, and to prevent possible broken solder joints or connections.

RECOMMENDED ACTION: Repair | Consult Specialist

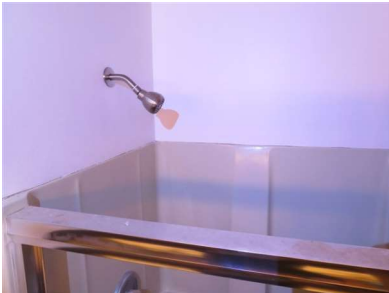
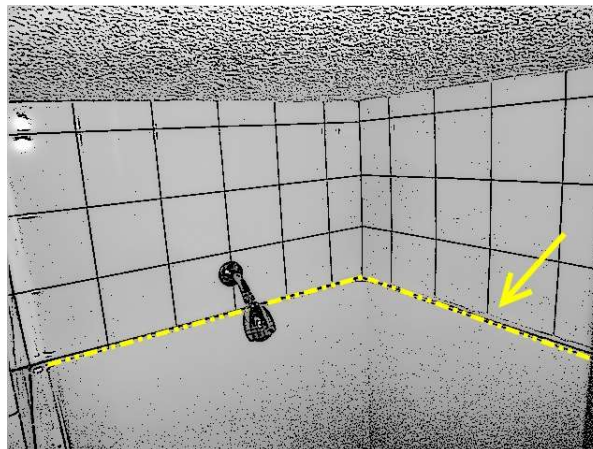
LOCATION: Bathroom - Master **SYSTEM:** Plumbing

CONDITION: **Shower enclosure top edge** requires effective sealing.

IMPACT/CONSEQUENCES: These open areas will likely compromise the effectiveness of the enclosure in preventing moisture from seeping into walls and causing damage associated with infiltration. If moisture gets behind the surround it may result in organic growth (mold, mildew, fungus) in the lower open seams, under the lower caulk seams, or behind the surround. Failure to provide effective repairs can result in organic growth, water damage, and costly repairs to the wall, floor, or areas below the shower enclosure.

RECOMMENDED ACTION: Repair | Consult Specialist

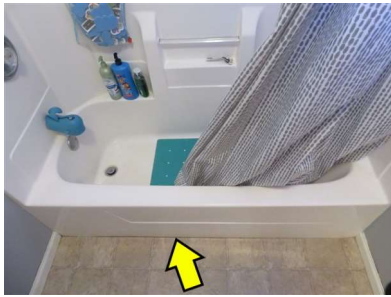
LOCATION: Bathroom - Master, Upper

SYSTEM: Plumbing

RECOMMENDED ACTION: Repair | Maintain as required to prevent infiltration | Consult Specialist

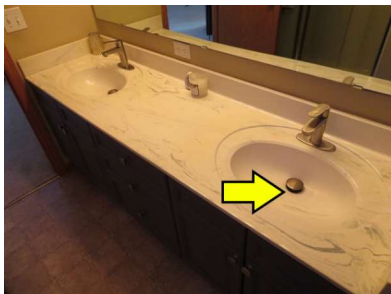
LOCATION: Bathroom - Upper **SYSTEM:** Plumbing
CONDITION: **Manufactured solid-surface** countertop (integrated basin) has cracks at the drain
EXPLANATION: Manufactured solid-surface countertops may develop stress cracks at or near the drain connection if the drain connections were not made in accordance with the manufacturer's instructions. Physical impacts can also cause chips and cracks.
IMPACT/CONSEQUENCES: Cracks in the surface of the bowl will ultimately result in leaks and water damage. The recommended action is to replace the sink.
RECOMMENDED ACTION: Monitor for Leaks | Replace

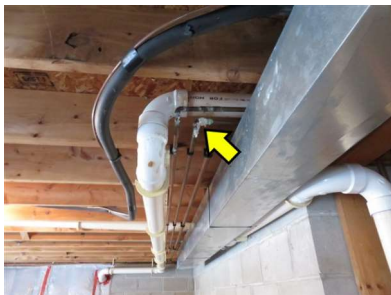
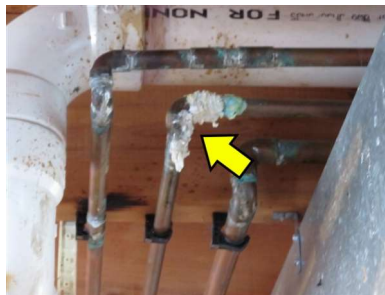
LOCATION: Basement **SYSTEM:** Plumbing

CONDITION: Water distribution pipe, connection, or valve **leaking or indication of leaking**

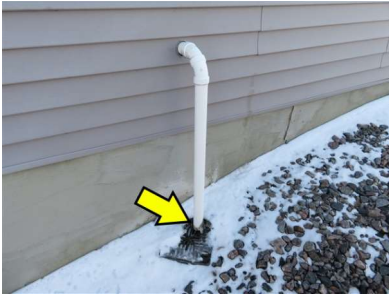
LOCATION: Exterior Left **SYSTEM:** Plumbing

CONDITION: Sump pump drain pipe is **discharging into an underground pipe**

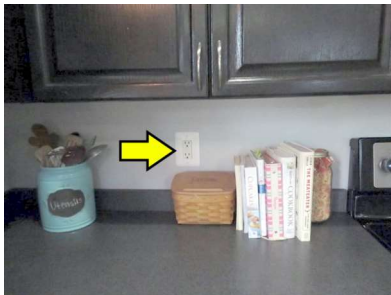
LOCATION: Laundry Room **SYSTEM:** Electrical
CONDITION: GFCI outlet recommended (SAFETY UPGRADE)

EXPLANATION: GFCI circuitry gives extra protection over a regular receptacle. Circuit protection may not have been required at the noted location(s) at the time the home was built or when the electrical service was updated. Circuit protection is recommended at the noted location(s) and other locations where they may now be required for safety.

IMPACT/CONSEQUENCES: The GFCI receptacle is provided as a safety device in locations where the presence of water increases the risk of electrical shock. Generally recommended where a outlet is within 6 feet of an area that dispenses water (sinks, showers, tubs, laundry area, wet bars, etc.). The absence of circuit protection at the noted location(s) may result in serious injury and possibly death from electrical shocks. Installation by a licensed contractor is advised.

RECOMMENDED ACTION: Recommended Safety Upgrade | Consult Specialist

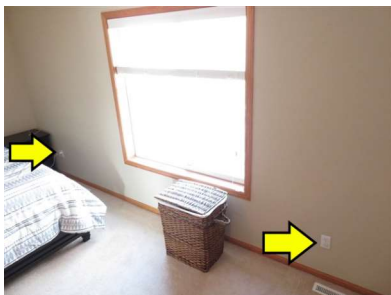
LOCATION: Bedroom - Master **SYSTEM:** Electrical

CONDITION: Electrical outlet box is **not adequately or properly secured**

IMPACT/CONSEQUENCES: A loose outlet box may in certain circumstances present a risk of fire and electrical shock should the outlet box be pulled out or apart from the connecting conduit and damaging wires. Loose outlet boxes should be properly installed to ensure they are properly positioned and secured so they may be safely used as intended.

RECOMMENDED ACTION: **Safety Concern** | Repair

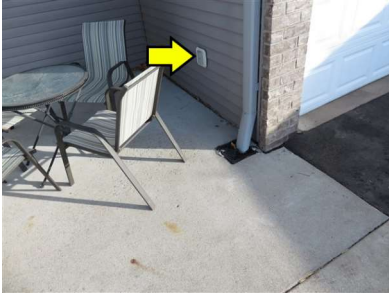
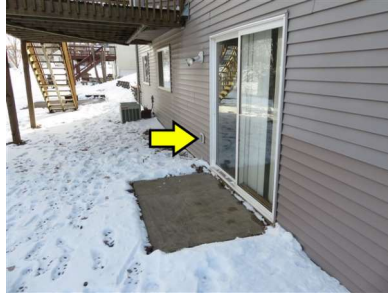
LOCATION: Exterior Outlets **SYSTEM:** Electrical

CONDITION: Exterior electrical weather resistant outlet cover outdated

IMPACT/CONSEQUENCES: This condition may expose the outlet to risks including shorting, damage, and deterioration. Outlet covers displaying damage or are ineffective at preventing moisture infiltration should be immediately replaced. This condition is a **safety concern** and repairs should be a priority.

RECOMMENDED ACTION: Safety Concern | Replace | Consult Specialist

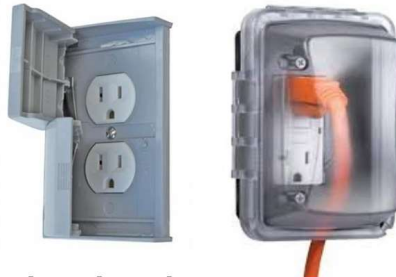
outdated outlet

**recommended
outlet**

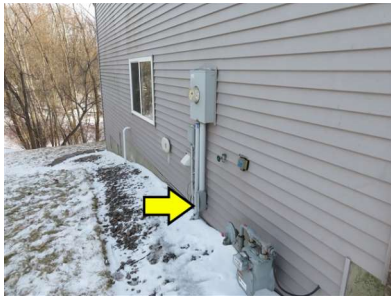
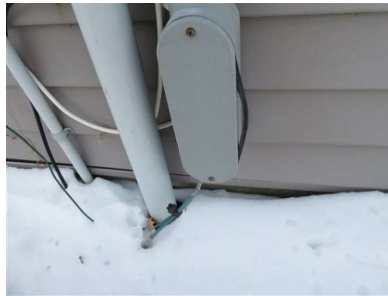
LOCATION: Exterior Left **SYSTEM:** Electrical

CONDITION: Exterior junction box is not weather-tight

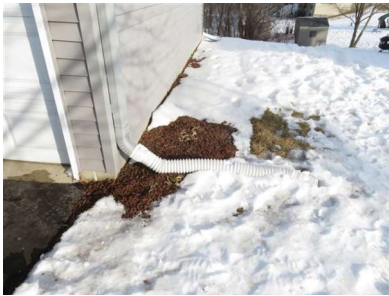
2

**LOCATION:** Downspouts - Various Locations **SYSTEM:** Roof**CONDITION:** Downspout tail piece performance is suspect (ribbed extension)**EXPLANATION:** A section of the downspout is observed to be of a style, type, or configuration that does not appear to be suitable to assuring discharge water will be free flowing and discharge away from the foundation wall effectively. This may include flexible or "ribbed" sections, slope, or drain tile. Ribbed drains do not rinse clean causing a build-up of debris within the downspout causing blockage, which may attract rodents which may nest in the ribbed section of the downspout causing additional blockage.**IMPACT/CONSEQUENCES:** Downspouts are a key component in the controlled drainage of run-off water away from the home's exterior elements. Poorly designed or configured downspout end terminations may result in water saturation of soils near the foundation during rains, which in turn can result in basement moisture or leakage issues. It is recommended that the point of discharge be at least 6' (2 m) from the foundation; repair should include replacing the downspout extension. The downspout assembly should assure that water freely flows and drains at a suitable distance from the foundation wall.**RECOMMENDED ACTION:** Monitor closely.

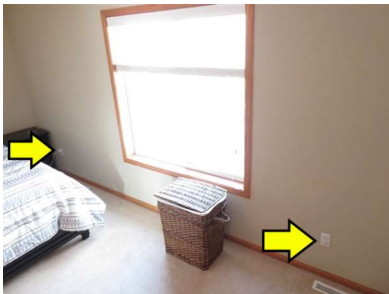
5

**LOCATION:** Bedroom - Master **SYSTEM:** Electrical**CONDITION:** Electrical outlet box is **not adequately or properly secured**

EXPLANATION: An electrical outlet box is not adequately or properly secured.

RECOMMENDED ACTION: **Safety Concern** | Repair

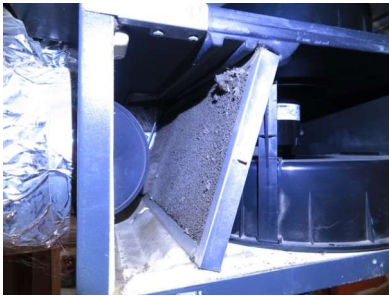
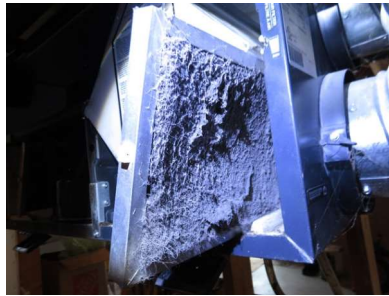
6

LOCATION: HRV (Heat Recovery Ventilator/ Air Exchanger) **SYSTEM:** Heating/Cooling

CONDITION: The HRV / Air exchange unit and filters need maintenance

RECOMMENDED ACTION: Replace; Clean If Reusable Type

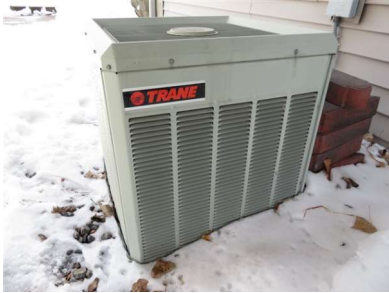
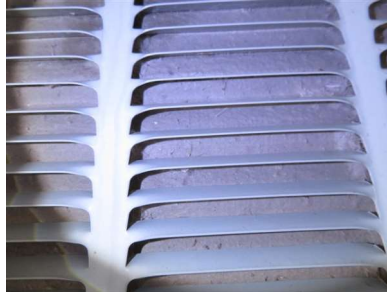
7

LOCATION: Exterior Rear **SYSTEM:** Heating/Cooling

CONDITION: Condenser unit fins or screen clogged or becoming clogged

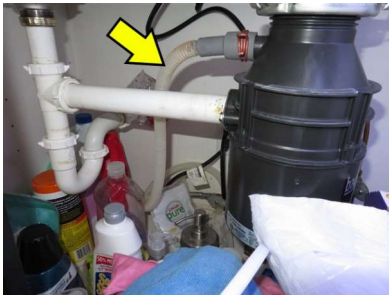
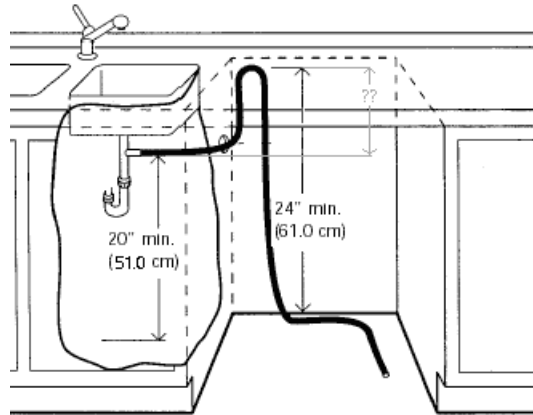
11

LOCATION: Kitchen **SYSTEM:** Plumbing

CONDITION: Drain pipe configuration or connection from dishwasher non-conforming

IMPACT/CONSEQUENCES: This is a safety and sanitary issue. If the kitchen drain backed up, the "greywater" could easily flow back into the dishwasher if there was no high loop to provide backflow resistance.

RECOMMENDED ACTION: Health Concern | Replace, Repair, or Adjust

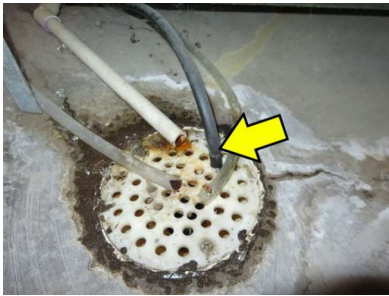
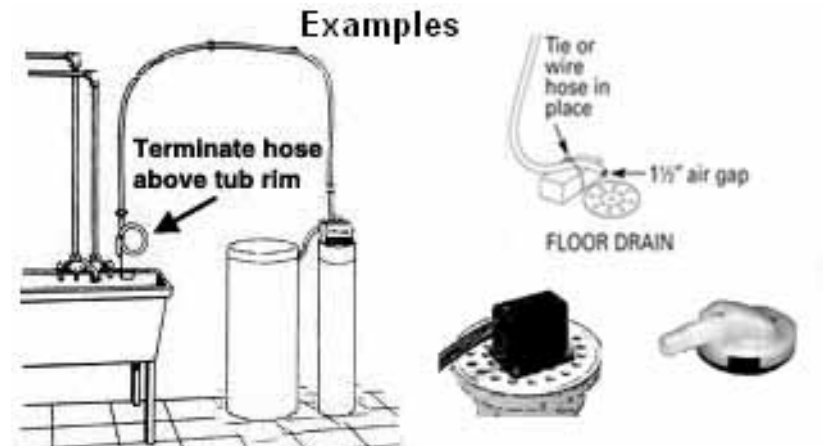
12

**LOCATION:** Water Conditioner (softener), Floor Drain **SYSTEM:** Plumbing**CONDITION:** Drainage configuration is potential health concern (cross-contamination)

EXPLANATION: The configuration of the drainage piping from the water conditioner allows for the possibility of “cross-contamination” of potable water and gray (waste, contaminated, or unsafe) water. A cross-connection is an unprotected actual or potential connection between a potable water system used to supply water for drinking purposes and any source or system containing unapproved water or a substance that is not or cannot be approved as safe, wholesome, and potable. Although many manufacturers are installing built-in check valves in water softeners, it is important to be aware of this possibility since the presence of a check valve can not usually be verified. The end of a drain, hose, or pipe from a potable water source should not terminate below the rim of a sink, drain, sump pump, waste lift system, or tub. Additionally, there should be a minimum of 1½ inches of separation of the potable drainage piping to a drain grate or floor.

IMPACT/CONSEQUENCES: This drainage configuration is a potential risk to health. A plumber may be required to investigate and implement corrective rework to assure proper installation of the drainage system and components to prevent backflow and contamination of the potable water system.

RECOMMENDED ACTION: Health Concern | Repair | Consult Specialist

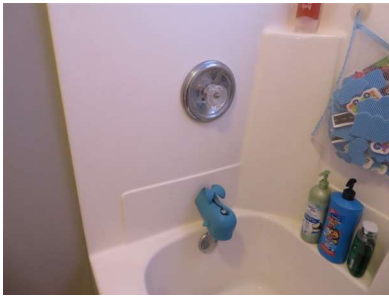
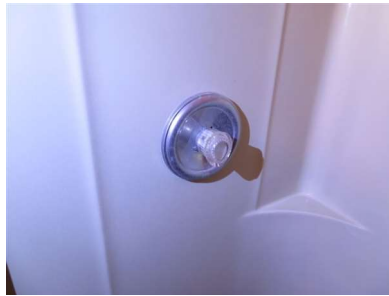
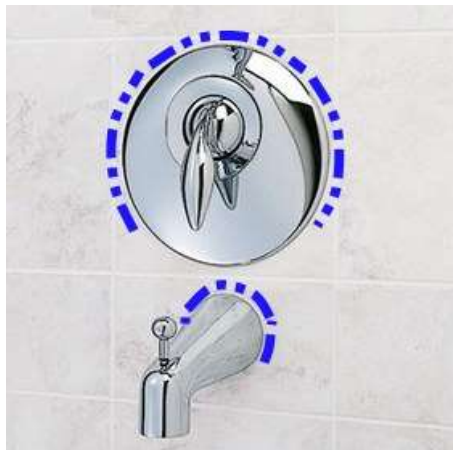
13

LOCATION: Bathroom - Master **SYSTEM:** Plumbing

CONDITION: Caulking is incomplete at bathtub/shower spout, taps, or wall penetrations.

EXPLANATION: The faucet spout, taps, handles, or other wall penetrations are observed to have incomplete or open caulking. Caulking is required to provide an effective barrier against water penetration.

IMPACT/CONSEQUENCES: Caulking is a preventative action to keep water from seeping into walls, and causing damage associated with leaks. Failure to provide effective sealing can result in damage and costly repairs.

RECOMMENDED ACTION: Repair

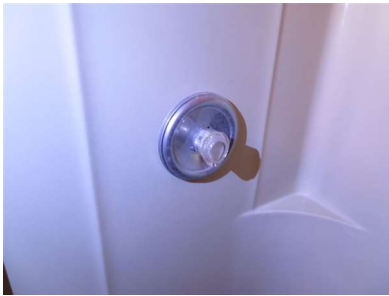
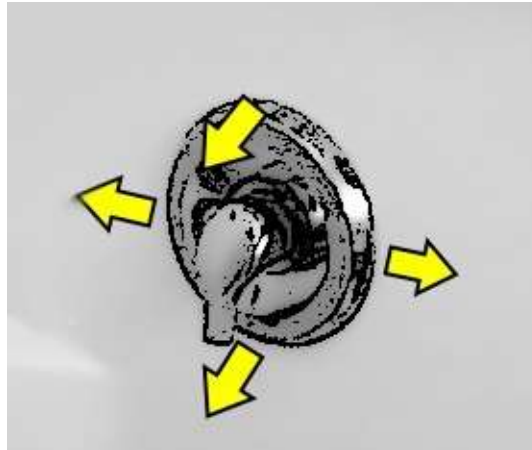
14

LOCATION: Bathroom - Master **SYSTEM:** Plumbing

CONDITION: Shower tap installation concerning (loose)

EXPLANATION: The tap is observed to be installed in such a manner that when pulled or turned to dispense water the entire tap (handle) mechanism has excessive movement, or is not properly secured to prevent it from sliding side to side, pulling out, or moving away from the shower enclosure wall.

IMPACT/CONSEQUENCES: The faucet should be installed correctly so it may be used as intended and it can remain sealed to prevent water infiltration behind the faucet, and to prevent possible broken solder joints or connections.

RECOMMENDED ACTION: Repair | Consult Specialist

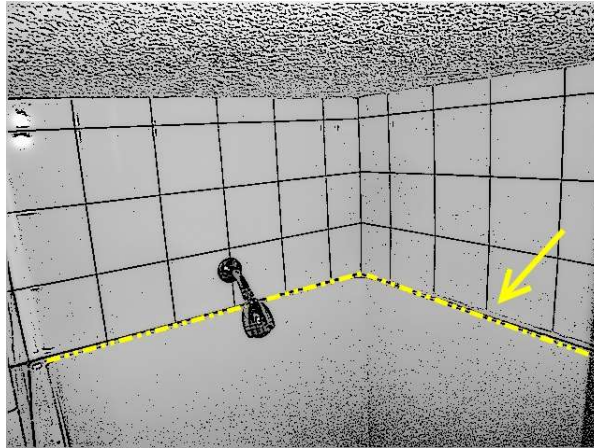
CONDITION: Shower enclosure top edge requires effective sealing.

EXPLANATION: The shower enclosure top edge caulk requires maintenance or is observed to have unsealed areas (gaps, cracks, openings, etc.) along the top edge of the material (tile, plastic, fiberglass, etc.) that may permit infiltration behind the enclosure.

IMPACT/CONSEQUENCES: These open areas will likely compromise the effectiveness of the enclosure in preventing moisture from seeping into walls and causing damage associated with infiltration. If moisture gets behind the surround it may result in organic growth (mold, mildew, fungus) in the lower open seams, under the lower caulk seams, or behind the surround. Failure to provide effective repairs can result in organic growth, water damage, and costly repairs to the wall, floor, or areas below the shower enclosure.

RECOMMENDED ACTION: Repair | Consult Specialist

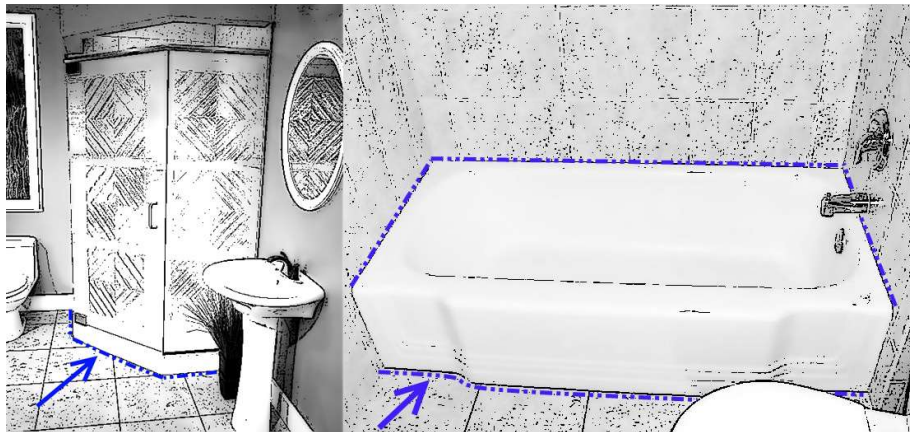
CONDITION: Caulking is incomplete or open at bathtub edges, shower/bathtub and floor junction, or shower/bathtub wall junction inside and outside the plane of the shower or tub

EXPLANATION: Caulking is required to prevent water penetration at junctions between the shower, bathtub, floor, adjacent trim, and walls. Caulking is observed to be inadequate to meet the intended requirements for sealing against water leaks at the bathtub or shower floor and wall junctions.

IMPACT/CONSEQUENCES: Caulking is a preventative action to keep water from seeping into walls and floors, and causing damage associated with leaks. Failure to provide effective sealing can result in damage and costly repairs. I recommend an application of caulk where currently required to prevent infiltration. I also advise monitoring these areas as over time the caulk may dry, shrink, and crack requiring a reapplication of the caulk.

RECOMMENDED ACTION: Repair | Maintain as required to prevent infiltration | Consult Specialist

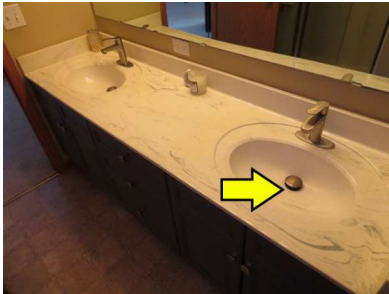
18

- LOCATION:** Bathroom - Upper **SYSTEM:** Plumbing
CONDITION: Manufactured solid-surface countertop (integrated basin) has cracks at the drain
EXPLANATION: Manufactured solid-surface countertops may develop stress cracks at or near the drain connection if the drain connections were not made in accordance with the manufacturer's instructions. Physical impacts can also cause chips and cracks.
IMPACT/CONSEQUENCES: Cracks in the surface of the bowl will ultimately result in leaks and water damage. The recommended action is to replace the sink.
RECOMMENDED ACTION: Monitor for Leaks | Replace

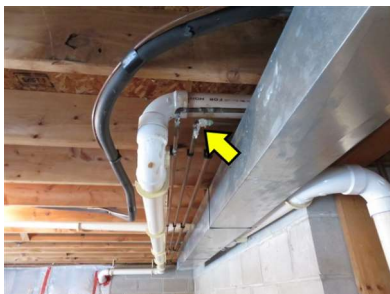
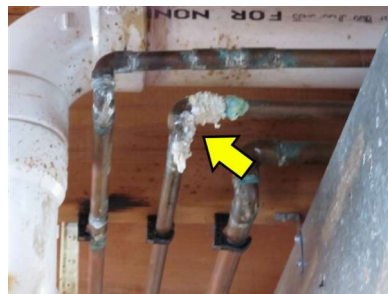
20

LOCATION: Basement SYSTEM: Plumbing

CONDITION: Water distribution pipe, connection, or valve **leaking or indication of leaking**

EXPLANATION: A leak or indication of leaking on piping, valves, or connections, is noted in the water distribution system. Indications may include an active leak, or mineral build-up or corrosion, that may be accumulate or be present when there is a slow leak. Very slow leaks may be temporarily plugged by this mineral build-up.

IMPACT/CONSEQUENCES: Leaks in water distribution system can lead to water damage to interior finishes and belongings, and can result in expensive repairs. Indications of leaks should be thoroughly investigated and required repairs should be performed by a Specialist. Left uncorrected, minor leaks can permit mold and rot to occur which can have significant effects to the health of the home's occupants and the integrity of the structure. The source and cause of the leak should be investigated and remedial action should be a priority.

RECOMMENDED ACTION: Repair | Consult Specialist

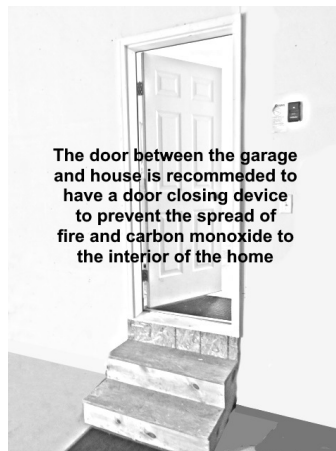
CONDITION: Garage/house door; door closer is missing, inoperable, or ineffective.

IMPACT/CONSEQUENCES: A door that connects the house with an attached garage, when it does not close and latch under the control of a suitable door closer or when it is missing, may be considered a safety concern, as fumes and fire from the garage may migrate and spread into the house. A mechanism for door closure when installed correctly, helps ensure the door automatically closes, latches, and seals when the door is released. Adjustments to the door or door hardware may be necessary for the correct operation of the door closer.

RECOMMENDED ACTION: **Safety Concern | Fire and Safety Upgrade Recommendation**

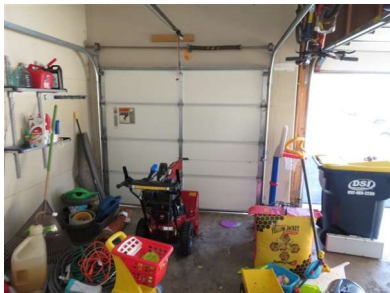
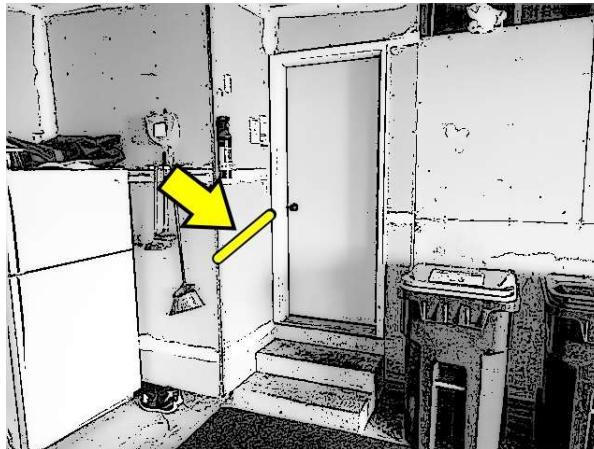
27

LOCATION: Garage Vehicle Door (single door) **SYSTEM:** Exterior

CONDITION: Vehicle door opener operation unsatisfactory. (hold button)

EXPLANATION: The vehicle door opener button must be held in to close the door completely. The home inspector is not required to correct these conditions to evaluate the opener.

IMPACT/CONSEQUENCES: The intended safe and correct operation of the door opener could not be verified as the unit failed to operate correctly under normal operating conditions and with installed control devices.

RECOMMENDED ACTION: Adjust, repair, or replace

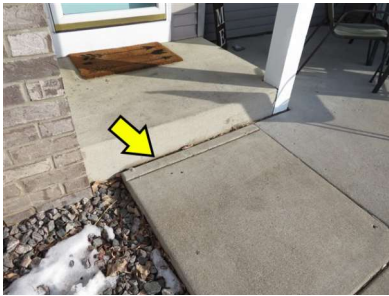
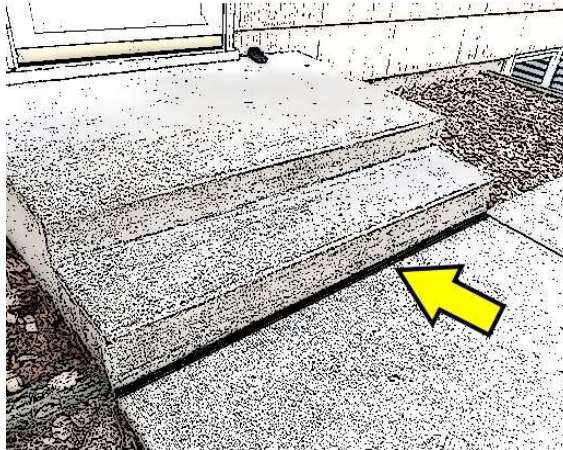
29

LOCATION: Exterior Front **SYSTEM:** Exterior

CONDITION: Walkway/stairway junction has open gaps, cracks, or seams.

EXPLANATION: Walkway / stairway junction has open gaps, cracks, or seams between the walkway and stairs that may allow water to penetrate and get underneath or between the walkway or stairs which may result in "frost push" causing additional separation, heave, or settlement.

IMPACT/CONSEQUENCES: This condition may promote undesired effects, which may include issues such as moisture problems at the home's foundation, soil erosion, or settling and heaving of the concrete walkway or step. Filling this gap with a nonabsorbent material such as expandable foam to prevent additional frost push is recommended by many professionals. Large gaps may be a SAFETY CONCERN by creating a trip hazard and causing injury. Advice from a Specialist is recommended especially for larger separations.

RECOMMENDED ACTION: Repair | Replace | Consult Specialist

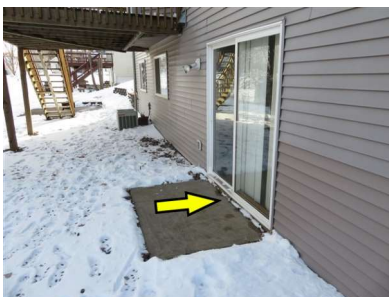
30

LOCATION: Exterior Rear **SYSTEM:** Exterior

CONDITION: Concrete pad has separated from structure

EXPLANATION: The concrete pad at the noted location was observed to have shifted, such that this movement has caused separation from the foundation. Some causes of this condition may be settlement, heave, or frost push.

IMPACT/CONSEQUENCES: Gaps between the pad and structure are susceptible to moisture accumulation and frost expansion which may promote additional separation. The gaps should be properly filled with a nonabsorbent material and caulked. Review by a concrete Specialist for suggestions of remedial action is recommended.

RECOMMENDED ACTION: Recommend Review by a Specialist

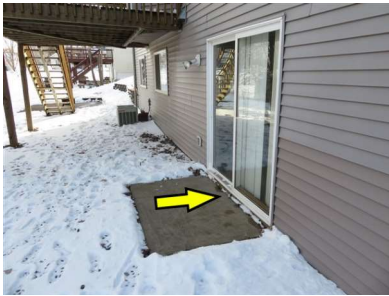
31

LOCATION: Exterior Rear **SYSTEM:** Exterior

CONDITION: Concrete pad or landing is sloped towards foundation -

EXPLANATION: A concrete pad or landing has a slope that will result in water flowing towards or pooling at the foundation of the house or garage.

IMPACT/CONSEQUENCES: Concrete pads and landings should be sloped to promote drainage away from the foundation of the house or garage. Water accumulation near the foundation may lead to foundation and basement dampness issues. In some cases, frequent saturation of soils may result in erosion of soils below the footings, and in combination with soil pressure and frost heave, can result in damage to the foundation. Sealing of seams between the concrete pad/landing and structure is recommended. Replacement may have to be considered.

RECOMMENDED ACTION: Repair | Consult Specialist

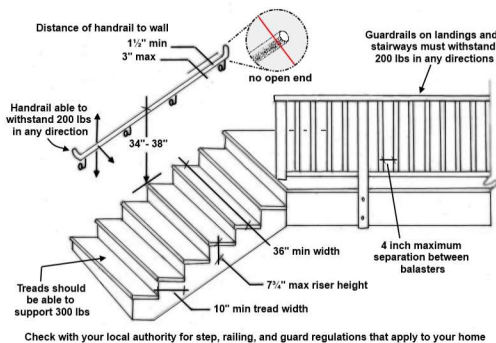
CONDITION: **Exterior stair hand railing/guard is missing or non-conforming**

EXPLANATION: Handrails that are an approved dimension and easy to grasp (by adults and children) are recommended on stairs with two or more risers; both sides if stairs are over 48 inches wide or every 48 inches on wider stairs, must be 34 - 38 inches above the stair tread nosing, must extend from directly above the bottom riser to directly above the top riser, be continuous for the entire length of a flight of stairs, ends be returned to the wall or terminate in a newel post, have a space of not less than 1½ inches between the handrail and the wall, must support a 200 lb. load, have a circular cross section of 1¼ inches to 2⅝ inches or equivalent with ⅛ radius edge (2X4 or other dimension lumber placed on edge or flat is not acceptable).

IMPACT/CONSEQUENCES: The primary function of interior railings is to protect people from falling and being injured. There is indication of poor design, construction, or maintenance, such that the railings do not appear to be in a condition that meets its intended function of protecting people from the risk of injury. Failure to correct railing deficiencies is a safety issue, and in some cases may have legal consequences where a person is injured as a result of neglecting to provide adequate safety provisions.

RECOMMENDED ACTION: **Safety Concern** - Recommended Installing

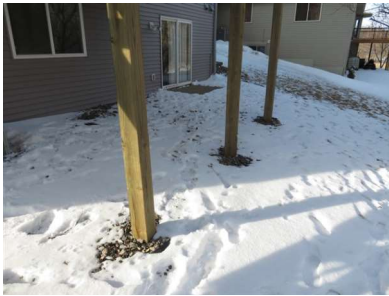
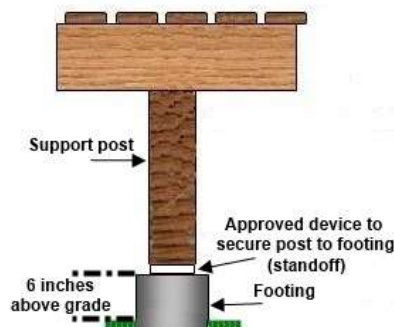
34

LOCATION: Deck **SYSTEM:** Exterior

CONDITION: Support column (post) concerning - Not on a footing raised to recommended minimum height

IMPACT/CONSEQUENCES: Support columns that are in contact with or close to the ground or horizontal surface will tend to rot or rust at the bottom, as they are in an environment where the lower portion of the column will be damp over extended periods of time. Although some natural and treated woods are more resistant to rot than others, all wood will over time deteriorate when in contact with the ground and soil moisture. In addition to the deterioration concerns of the wood support columns, is the damage that may occur to the bottom of the columns as they wick moisture during colder climates and then go through freeze/thaw cycles which may expand and shred, tear, or "mushroom out" the bottom of the column resulting in ongoing damage and deterioration over time. Metal columns will also deteriorate (rust / corrode) when exposed to damp conditions for extended periods of time. The columns should be periodically monitored for; changes in the condition and loss of integrity. Replacement of the columns, if and when necessary, by a licensed contractor is advised. Note that the columns are crucial to the support structure of the deck, balcony, or stairway and structural failure may occur should the column(s) deteriorate to a degree that they can not bear their intended load.

RECOMMENDED ACTION: Monitor; Replace should severe wood rot, deterioration, or corrosion be observed | Consult Specialist | Recommended Upgrade

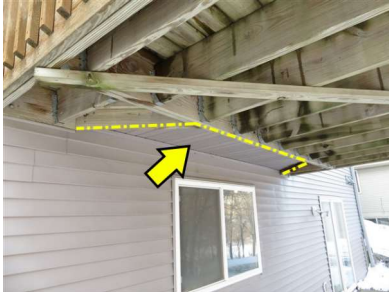
35

**LOCATION:** Deck **SYSTEM:** Exterior**CONDITION:** Cantilevered Wall / Deck attachment concerning**EXPLANATION:** The deck is observed to be attached to and supported by a cantilevered wall. This method of supporting the deck is a concern because the cantilevered wall may not have been designed to support the additional weight of the deck. Additional support columns and beams or properly framing the deck around the cantilevered wall are usually recommended and used to support this area of the deck.**IMPACT/CONSEQUENCES:** Improperly configured and supported decks attached to cantilevered walls may over time cause sagging and eventually structural failure of the cantilevered wall. Determining the weight bearing capacity of the cantilevered wall is beyond the scope of the inspector. This condition should be evaluated by a licensed contractor that is familiar with current methods and regulations for deck construction, to assure the deck attachment and support meets the current standards, local jurisdiction requirements, or the actual designed and anticipated load requirements of the deck.**RECOMMENDED ACTION:** Safety Concern | Review | Consult Specialist
