INSPECTION REPORT

Report Number
RHI 4561

Some City, Minnesota 55000

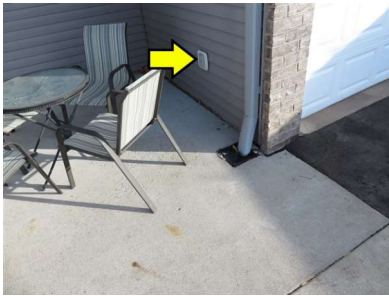
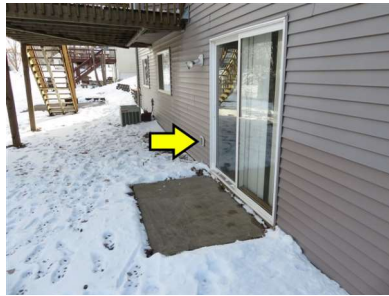
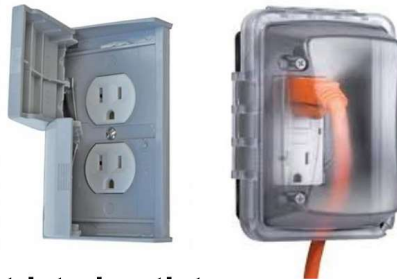
36

LOCATION: Exterior Outlets **SYSTEM:** Electrical

CONDITION: Exterior electrical weather resistant outlet cover outdated

IMPACT/CONSEQUENCES: This condition may expose the outlet to risks including shorting, damage, and deterioration. Outlet covers displaying damage or are ineffective at preventing moisture infiltration should be immediately replaced. This condition is a **safety concern** and repairs should be a priority.

outdated outlet recommended outlet

RECOMMENDED ACTION: Safety Concern | Replace | Consult Specialist

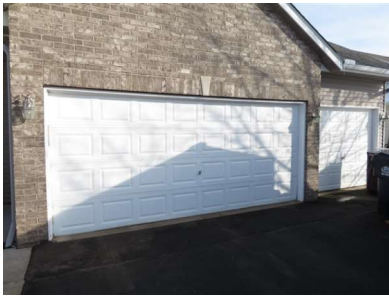
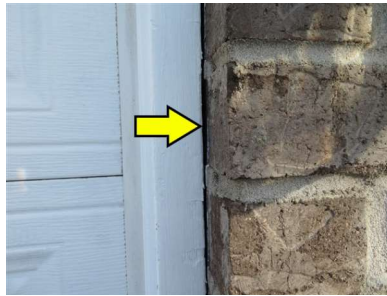
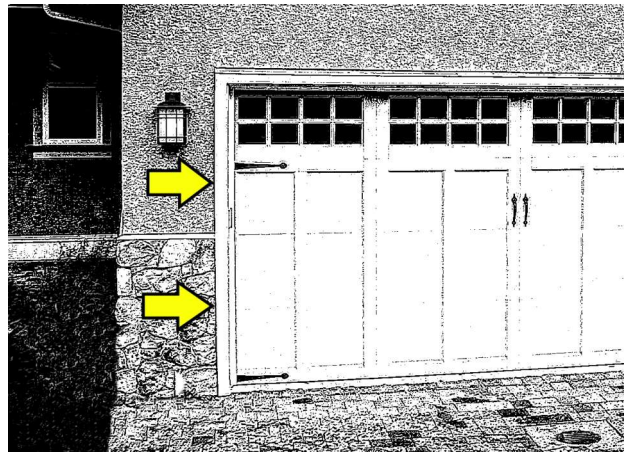
38

LOCATION: Garage Vehicle Door **SYSTEM:** Exterior

CONDITION: Garage vehicle door trim / wall cover junction requires caulking (general)

IMPACT/CONSEQUENCES: Caulking at these seams serves several functions, including preventing air, water, and pest infiltration, and restricting heat loss or gain through the exterior wall. Moisture has the greatest potential for damage; unintended water infiltration into the house can cause significant damage to surfaces and property, and if not corrected, may lead to damage and rot to structural elements. Caulking repairs are required at the noted location(s), and should be performed at the earliest opportunity. Preventative maintenance should include reviewing and repairing exterior caulking at all locations where required.

RECOMMENDED ACTION: Repair | Maintenance | Consult Specialist

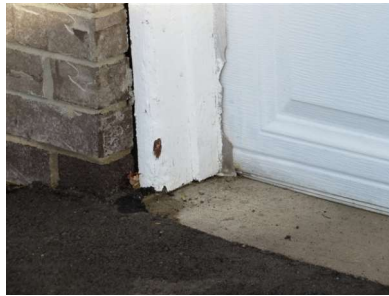
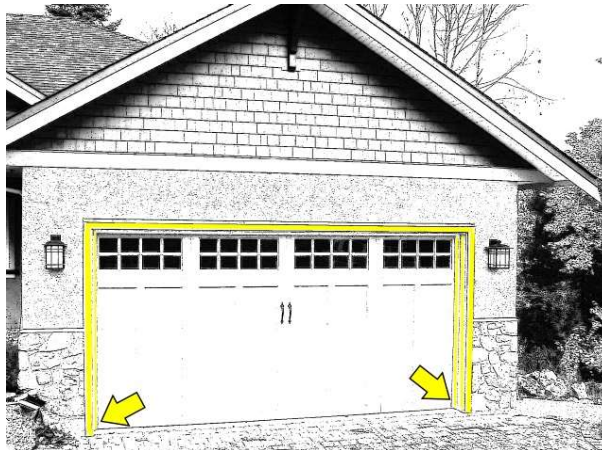
39

LOCATION: Garage Vehicle Door **SYSTEM:** Exterior

CONDITION: **Vehicle door trim** requires maintenance (paint, caulk, repair)

IMPACT/CONSEQUENCES: Failure to properly maintain exterior finishes will result in deterioration of the trims and wood elements, and left uncorrected, may result in water infiltration and damage to the wall structure or infiltration to interior elements.

RECOMMENDED ACTION: Recommended Maintenance

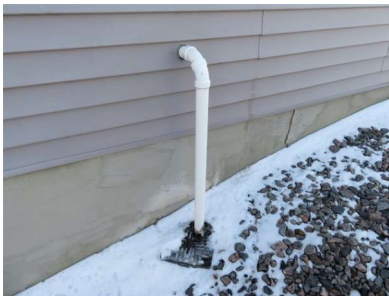
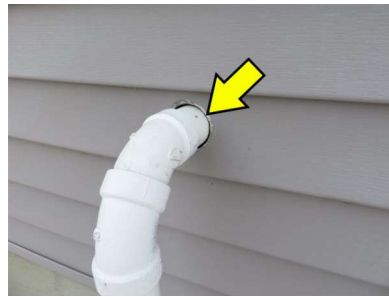
41

LOCATION: Exterior Left Side **SYSTEM:** Exterior

CONDITION: Wall penetration of sump pump drain pipe is not sealed at the exterior wall

RECOMMENDED ACTION: Repair

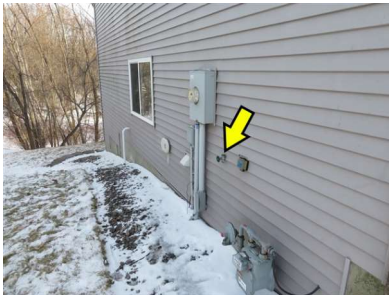
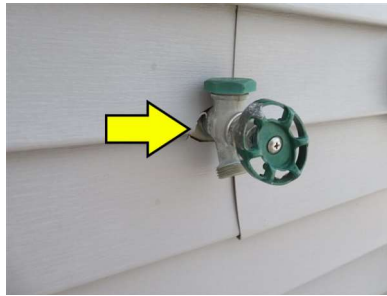
42

LOCATION: Exterior Left Side **SYSTEM:** Exterior

CONDITION: Wall penetration of faucet or water supply pipe is not caulked/sealed at exterior wall

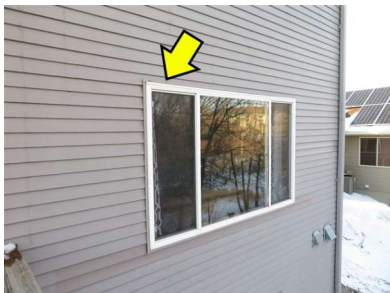
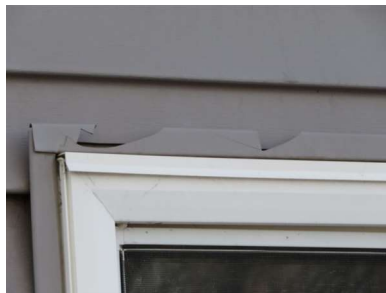
44

LOCATION: Exterior Rear **SYSTEM:** Exterior

CONDITION: Vinyl siding damaged (minor)

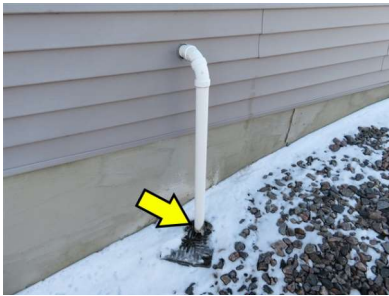
45

**LOCATION:** Exterior Left **SYSTEM:** Plumbing**CONDITION:** Sump pump drain pipe is **discharging into an underground pipe**

EXPLANATION: The sump pump drain pipe is discharging in a underground pipe near the home's foundation. The purpose of the sump is intended to collect and remove water from the soils near the foundation for discharge at a distance from the home. There is concern that this pipe, not being sealed at the top, having an unknown place of termination, or exposed to the possibility of freezing, may be clogged or damaged below the grade and not operating as intended. This will promote water saturation of soils at the foundation and footings, and may result in moisture-related problems in the basement.

RECOMMENDED ACTION: Recommend Modification | Consult Specialist

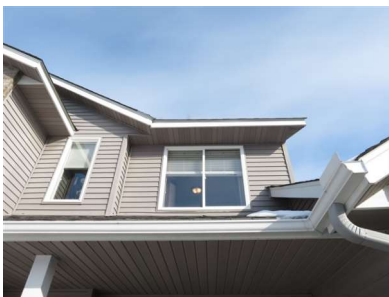
46

**LOCATION:** Roof - Front (upper) **SYSTEM:** Roof**CONDITION:** **Gutters not installed at all areas of roof edge**

EXPLANATION: Gutters have not been installed along all of the roof edges (upper and lower roof edges if applicable). Gutters provide a controlled means of collecting and discharging water away from the structure. Full depth 5 inch gutters are recommended.

RECOMMENDED ACTION: Recommended Upgrade | Consult Specialist

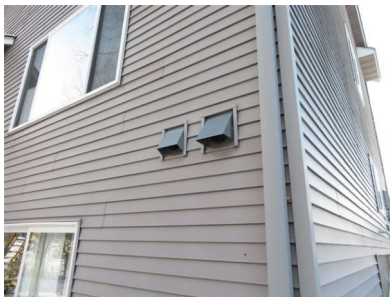
48

LOCATION: Exterior Rear SYSTEM: Heating/Cooling

CONDITION: The HRV / Air exchange **exterior vent maintenance recommendation**

RECOMMENDED ACTION: Recommended Maintenance | Consult Specialist

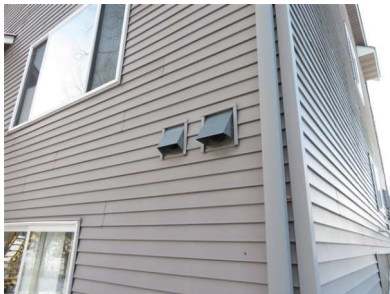
49

LOCATION: Exterior Rear SYSTEM: Insulation/Ventilation

CONDITION: Fresh air intake vent **maintenance recommendation**

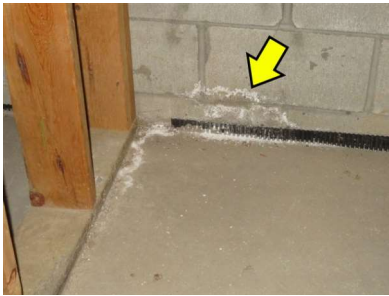
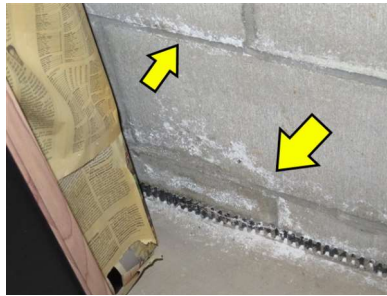
50

LOCATION: Foundation - Interior Front, Left **SYSTEM:** Structure

CONDITION: Efflorescence is observed on foundation

EXPLANATION: Efflorescence is a white powdery deposit of salts that forms on the surface of the foundation wall. This is an indication of wall dampness, with the leaching of salts being the result of moisture working its way through the foundation wall. Although the wall can be cleaned to remove efflorescence, the causes for this condition need to be addressed before the condition can be eliminated. Causes may include grading, clogged gutters, no gutters, poor performing gutters, or close downspout termination to the foundation.

IMPACT/CONSEQUENCES: Efflorescence is a consequence of moisture drawing out salts in the masonry or concrete, and depositing it on the surface; it is generally powdery-white in appearance. New masonry and concrete is particularly prone to displaying efflorescence in its first year, but this condition should diminish in extent over time. Ongoing and persistent efflorescence is an indication that excessive trapped moisture is working its way through the wall, and should be investigated by a masonry or foundation specialist for evaluation for cause and to establish remedial action. Failure to correct may result in deterioration or damage with potentially expensive repairs.

RECOMMENDED ACTION: Monitor

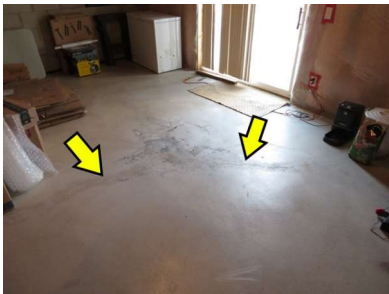
51

LOCATION: Basement **SYSTEM:** Structure

CONDITION: Indications of past or possibly current water infiltration on concrete floor

EXPLANATION: The examination of the concrete floor, could not ascertain whether the indications of moisture present at the time of inspection, were from a previous condition that has now been corrected or from a current condition that is ongoing or likely to happen again. Indications of current infiltration such as; puddles, wet flooring, etc. or past water infiltration such as; water trail stains, mold, mildew, efflorescence are observed.

IMPACT/CONSEQUENCES: The concrete floor in the area of concern should be monitored over time to ascertain whether there is an active leakage condition. Should a current leak condition exist, water penetration past the exterior wall system or floor may cause significant and costly damage to the structure, interior features, and interior contents of a home. Uncorrected water penetration can lead to mold and rot issues within the structure with possible consequential health effects and costly remedial actions.

RECOMMENDED ACTION: Monitor | Consult Specialist

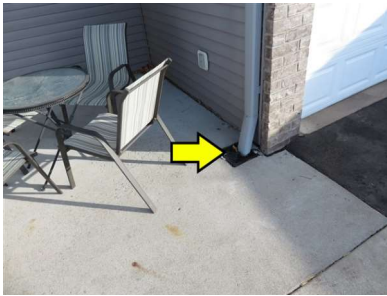
52

LOCATION: Downspouts - One or More Locations **SYSTEM:** Roof

CONDITION: Downspout below grade or hidden drainage provisions are concerning

EXPLANATION: Where a hidden or below grade drainage system is installed, there is usually no visual way to verify that drainage of water from the downspout into the below grade drain pipe is; not damaged from frost, restricted from debris accumulation, pest nesting, or settlement / heave crushing the drain tile, properly connected, properly sloped, and free flowing away from the foundation, walkway, patio, or driveway during all weather conditions. On older houses, these extensions may be cast iron, clay tile, or asbestos cement piping. On modern houses, the drain tiles below grade are often ABS or PVC plastic.

IMPACT/CONSEQUENCES: The absence of proper visible drainage provisions will likely promote water saturation of soils at the foundation and footings, and may result in frost and moisture-related problems with the foundation, basement, walkway, patio, and driveway. In this area of the country, frost can go down a minimum of 4 ft., and has gone to 7 ft. causing the below ground drainage provisions to freeze resulting in damage to drain tiles, frozen and clogged drain tiles, which may cause below grade leaks near the structure. This condition should be closely monitored; where basement dampness or foundation cracks are noted, remedial action is recommended to improve and assure effective drainage will occur.

NOTE: There may not be a good alternative for this condition, so monitor closely for issues associated with moisture such as foundation settling, basement moisture issues, walkways settling or heaving, etc.

Consulting a gutter Specialist is advised to discuss options to address this condition.

RECOMMENDED ACTION: Review | Monitor | Repair | Consult Specialist

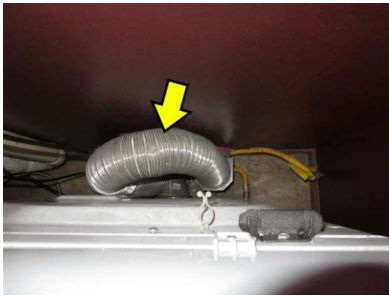
54

**LOCATION:** Laundry Room **SYSTEM:** Interior**CONDITION:** Clothes dryer vent ducting concerning (ribbed)

EXPLANATION: The dryer vent ducting is recommended to be metal (smooth rigid) and of a uniform diameter to the outside. Too much resistance from “ribbed” style ducting ruins efficiency by extending drying times. With enough resistance, the flow becomes so sluggish that the moisture in the air condenses on the pipes. This condensate attracts lint that sticks to the vent walls. Caked-on lint further impedes airflow and is a fire hazard. Extended run times are also hard on dryers, wearing them out more quickly. And finally, overworked dryers start blowing thermal fuses.

IMPACT/CONSEQUENCES: The use of materials other than approved smooth metal dryer vent may create the possibility of a fire hazard and/or may shorten the useful life of this appliance. Seams if taped, should be taped with an approved taping material that can perform well with high temperatures. Non-conforming tape materials may pose a safety concern.

RECOMMENDED ACTION: Safety Concern | Replace

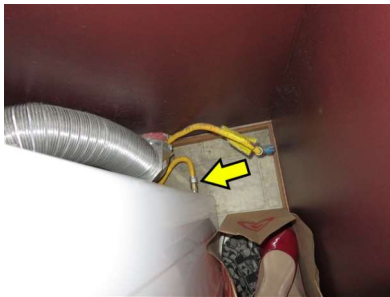
56

LOCATION: Laundry Room **SYSTEM:** Interior

CONDITION: Drip leg missing on gas connection. (Dryer)

EXPLANATION: The drip leg "T" in the gas line to an appliance is not observed where expected or could not be located in the course of inspection. A drip leg should be installed to help catch contaminants in the gas line.

IMPACT/CONSEQUENCES: The drip leg catches condensation in the gas line before it can cause problems with the operation of the appliance. The absence of a drip leg for all gas appliances should be considered a safety issue requiring immediate remedy.

RECOMMENDED ACTION: Safety Concern | Install | Consult Specialist

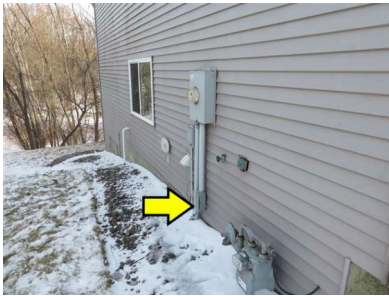
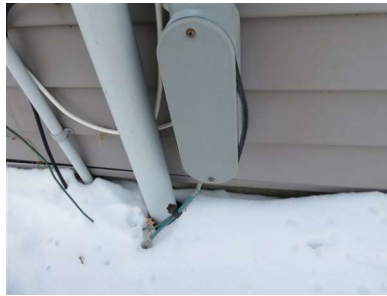
62

LOCATION: Exterior Left **SYSTEM:** Electrical

CONDITION: Exterior junction box is not weathertight
